RECONNAISSANCE SURVEY AND PRIORITIZED SURVEY PLAN: HIGH LINE CANAL CORRIDOR

Written and published for the High Line Canal Conservancy

Square Moon Consultants, Inc.

©High Line Canal Conservancy—October 2016

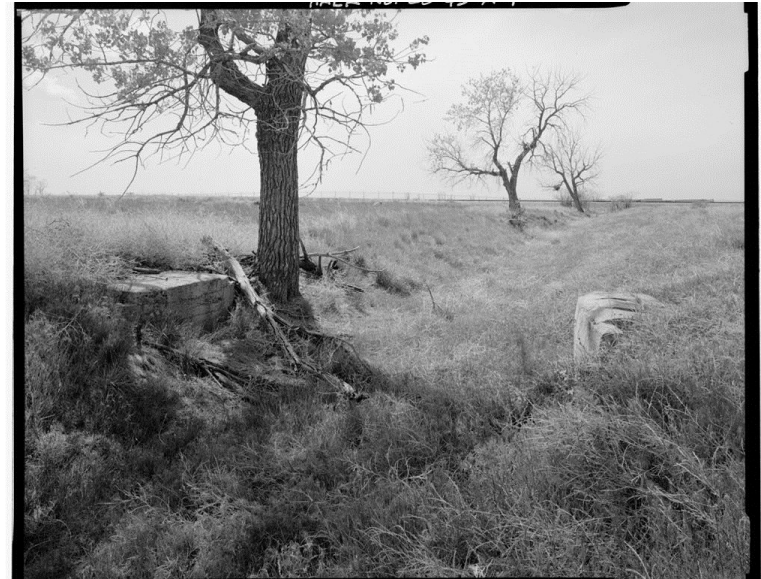
Exhibit 2-1: 1998 Photograph of the High Line Canal’s Sand Creek Canal Lateral on Rocky Mountain Arsenal. Source: Historic American Engineering Record, HAER CO-43-A.

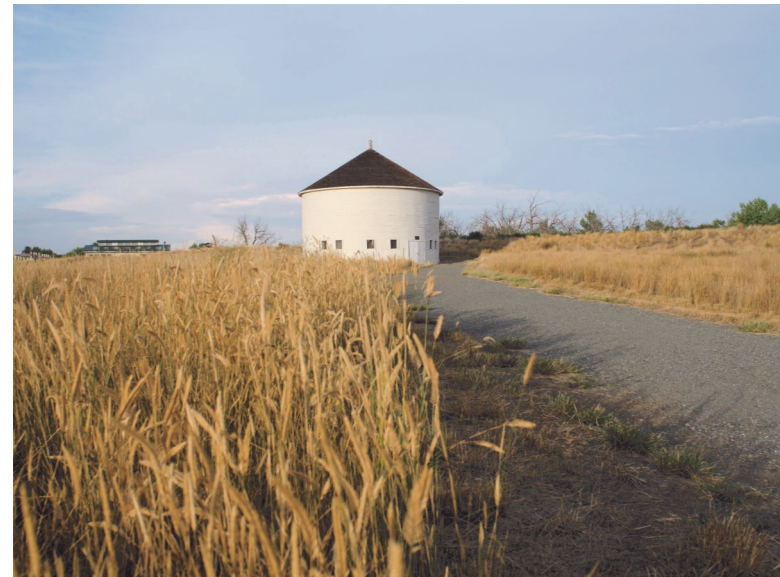
Exhibit 2-5. Ca. 1900 round milking barn at Delaney Farm. The Delaney family developed an extensive agricultural compound east of Aurora adjacent to the Canal during the late 19th and early 20th centuries.

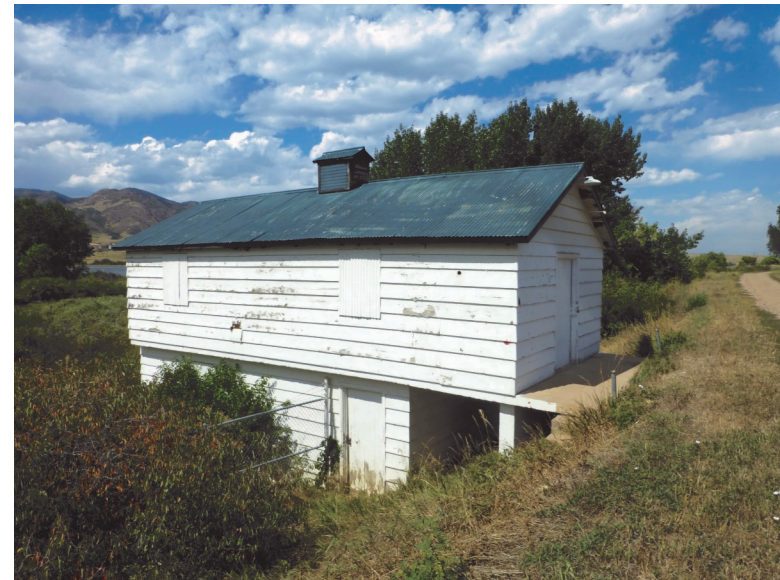
Exhibit 2-6. *The project documented the Alum House, an early 20th century Canal building that once functioned as a gauge station at the Platte Canyon Reservoir spillway.*

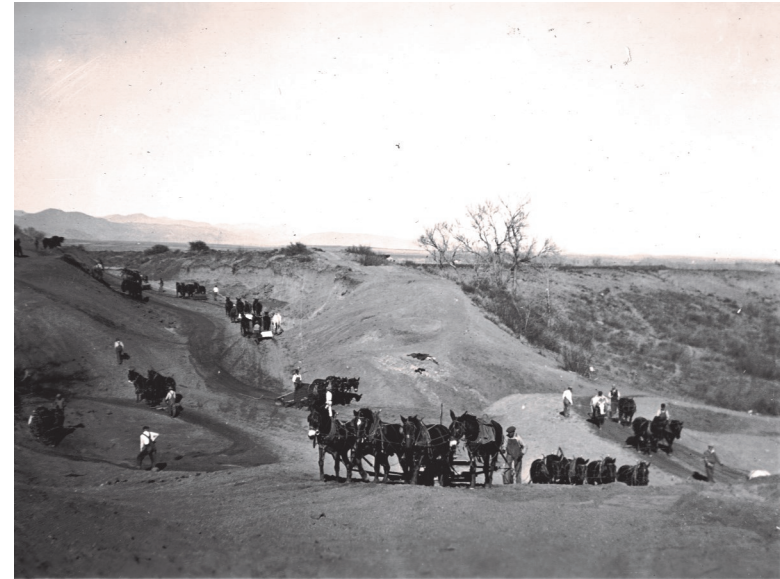
Exhibit 3-1: Photograph showing re-sloping of Canal. In 1933. Earth grading of the Canal using horse-and-slips, combined with manpower and simple tools, is reminiscent of the Canal's original 1879 to 1883 construction. Source: Denver Water, Album 41, p. 43, photo #3752.

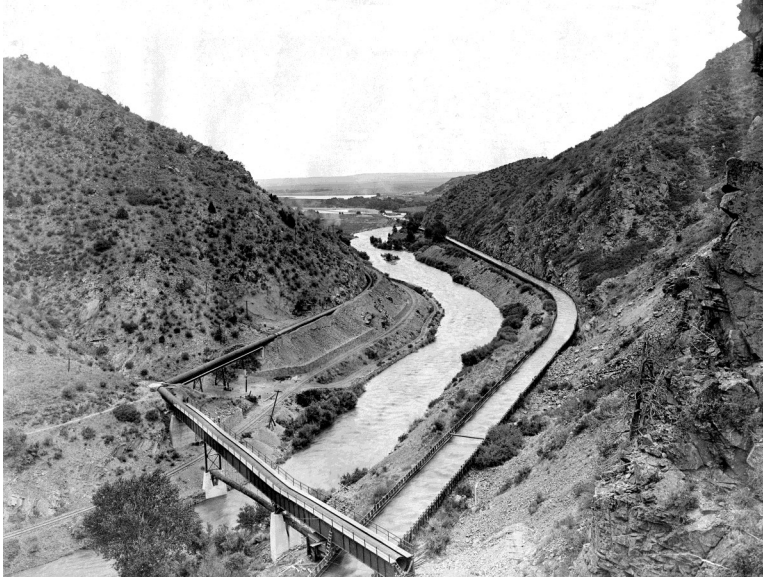
Exhibit 3-2: 1912 photograph showing original wooden bench flume just after it exits the tunnel, extending north parallel to the South Platte River. Source: Denver Water, Album 28, p. 80, photo #1109. (Photo also featured on front cover.)

created continual maintenance expenses. As such, the company's profits varied widely from year to year. In 1898, the Platte Land Company reported that the 17-year old bench flume in Platte Canyon was "now so much decayed that it would be unsafe to wish it another year...." The cost of a new flume was estimated at \$12,500, a sizeable cost at the time. In 1899 the company reported water rental and interest income at \$40,086 with maintenance costs and other expenses at \$22,579, providing a net income of \$17,507. In other years, income was much less or much more, depending on expenses and maintenance required (*Northern Colorado Irrigation Company Minutes*, Vol. 1 May 2, 1898, and May 1, 1899).

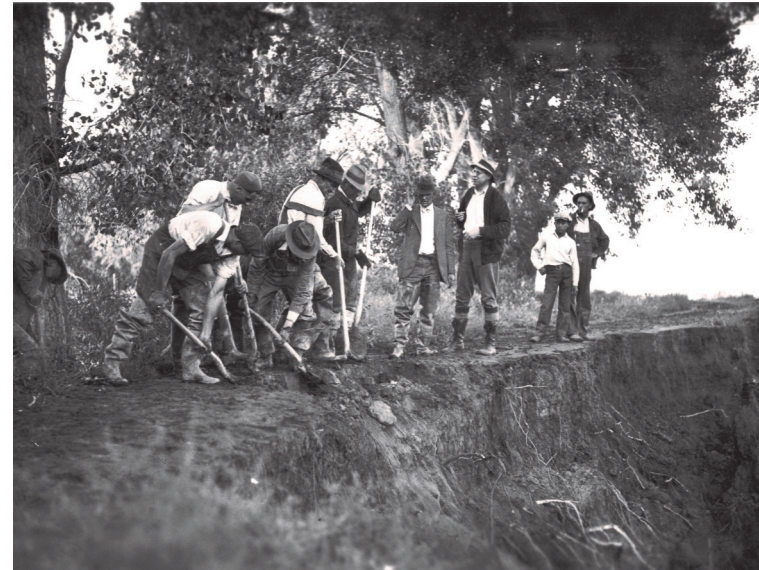
Exhibit 3-5: 1933 repairs to Canal bank washed out by "overtopping during storm." Source: Denver Water, Album 41, page 81, photo #3656.

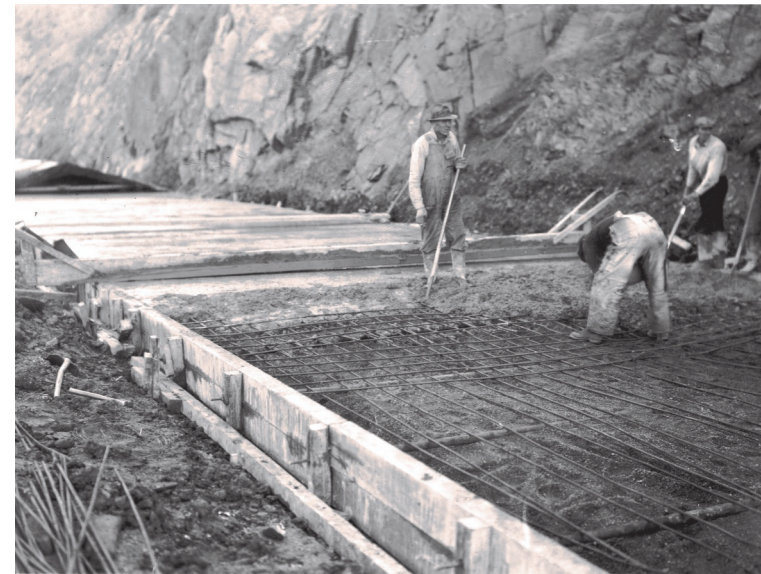
Exhibit 3-6: The bench flume at Waterton Canyon was subject to constant repair. This Nov. 18, 1934, photograph depicts the replacement of the timber floor with a new concrete floor slab. Source: *Denver Water, Album 41, page 20, photo #3973.*

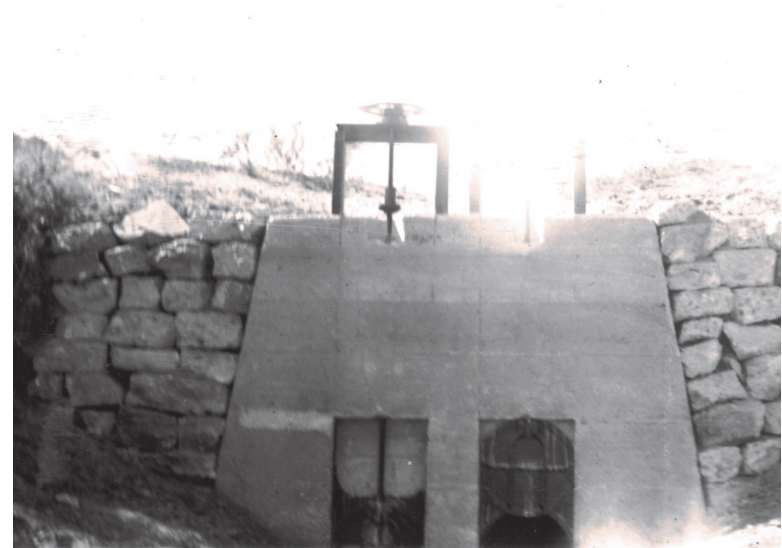
Exhibit 3-7: This photograph shows new twin headgate #79 after its installation in March 1939. The concrete rubble retaining walls suggest that a Depression-era work relief program may have been involved in the project. Source: Denver Water, Album 42, page 19, photo #6307.

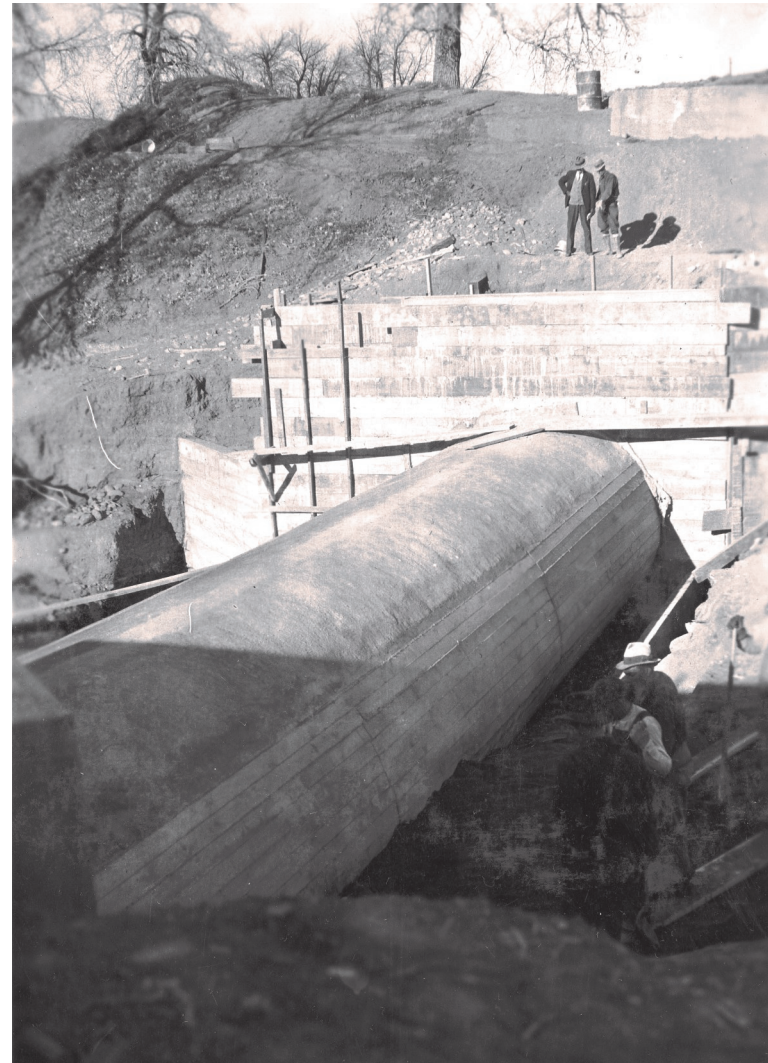
Exhibit 3-8: In February 1934, Denver Water installed a concrete siphon at Little Dry Creek. Source: Denver Water, Album 41, page 30, photo #3790.

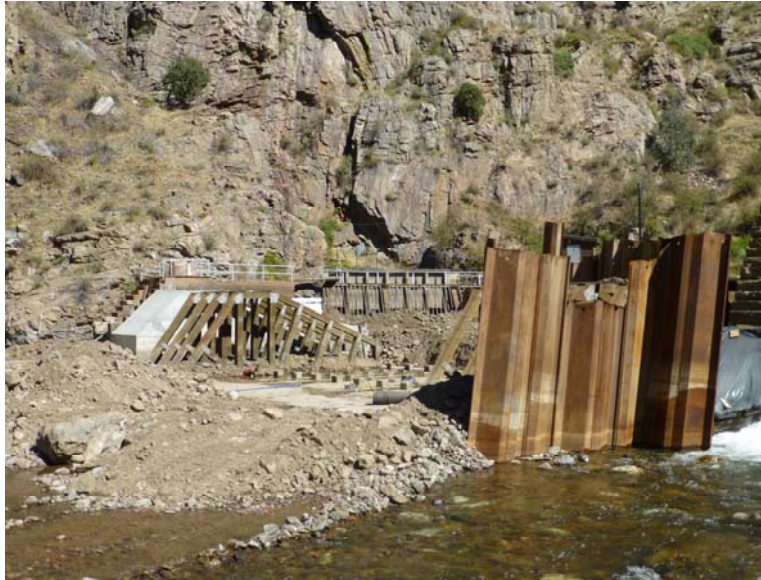
Site Number: bas_060_1 **Map Index:** 1

Additional Information: In the summer of 2016 (photo) Denver Water is rebuilding the dam; photo shows temporary cofferdam in river to allow construction out of the current.

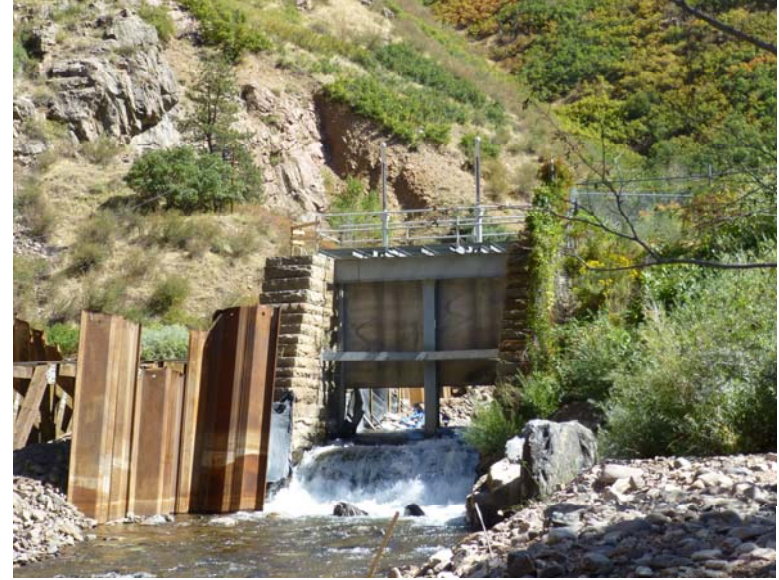
Site Number: bas_061_1 **Map Index:** 1

Ownership: Public, Denver Water
Additional Information: Channels river water into Tunnel, first through the grizzly and then through the control gates. Tunnel Inlet visible (photo) in the rock face above the 6th Gate from left.

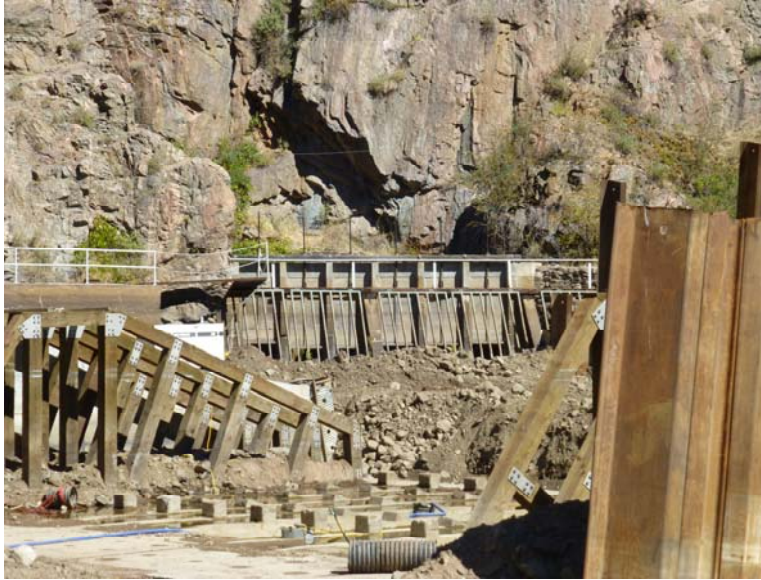
Site Number: bas_059_1; bas_057_1 **Map Index:** 1
Property Type: Structure–Diversion: Headgate
Description: High Line Canal Headgate
Significance: 4
Special Features: Grizzly (debris trap) in front of multiple individual gates in steel frame.

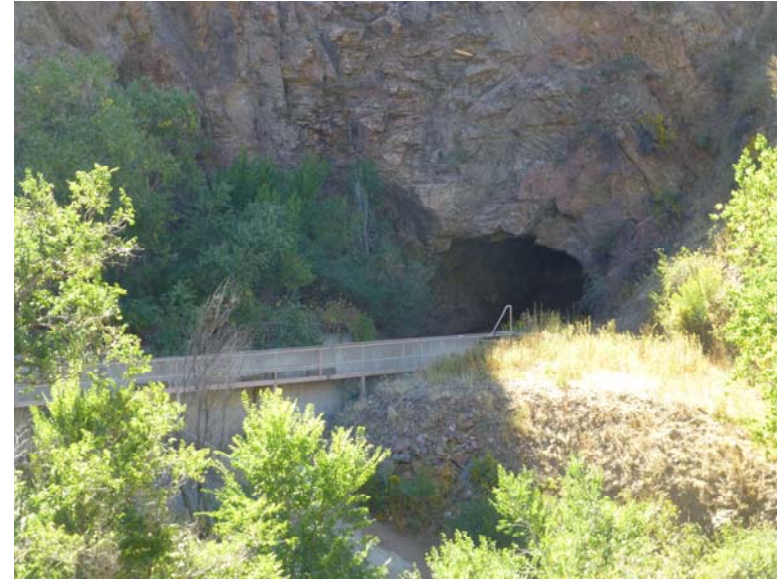
Site Number: bas_056_1; bas_056_2 **Map Index:** 1
Property Type: Structure–Conduit
Description: Tunnel Entrance; Tunnel Outlet (photo)
Significance: 4
Special Features: Form-cast concrete protection at entrance; natural stone portal at exit.

Ownership: Public, Denver Water
Additional Information: Tunnel moves water from Diversion Dam on South Platte River through mountain ridge that causes a natural bend in the river.

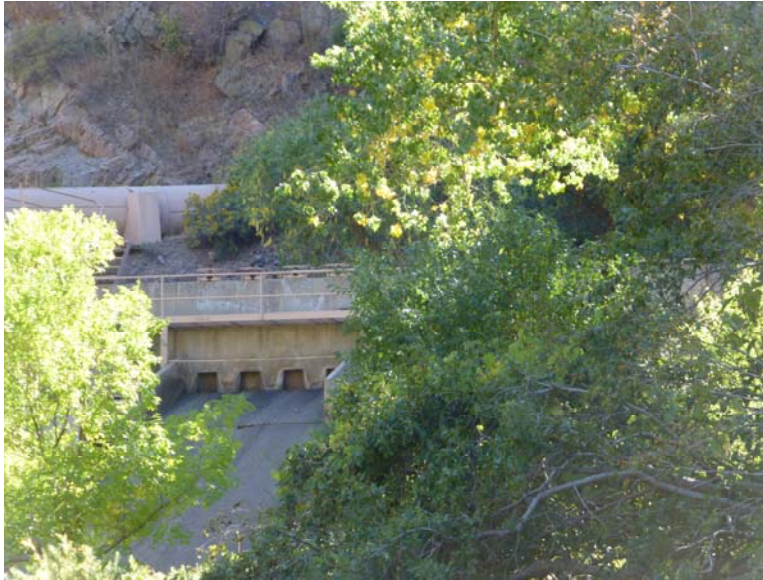
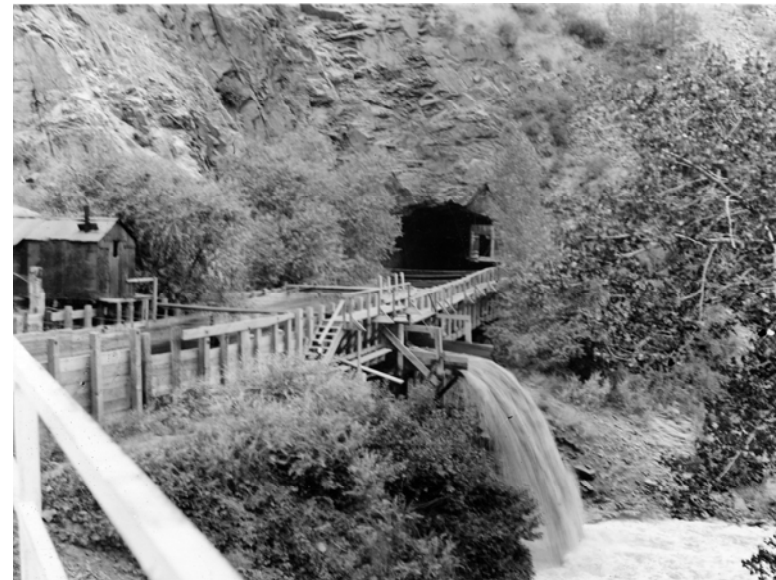
Site Number: bas_057_1 **Map Index:** 1

Property Type: Structure–Protection & Cleaning

Additional Information: At Tunnel Outlet, allows return of excess water in Canal to South Platte River via spillway and removal of sand prior to return. Historic photos to right courtesy of Denver Water, Album 42, p. 46, #4908, from 07-28-36 (top right), and Album, 42, p. 37, #5200 from 04-12-37 (bottom right).

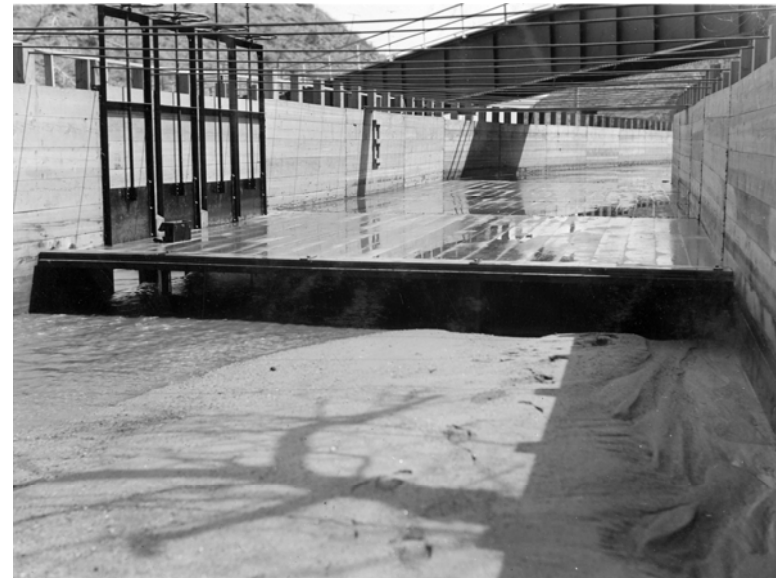
Site Number: bas_055_1; bas_055_2 **Map Index:** 1
Property Type: Structure–Conduit
Description: Rating Flume beginning with Debris Gate; end
Significance: 4
Special Features: Flume from Tunnel Outlet along South Platte River (Denver Water pipeline and bridge cross Canal and River to north [west] bank [photo top right]).

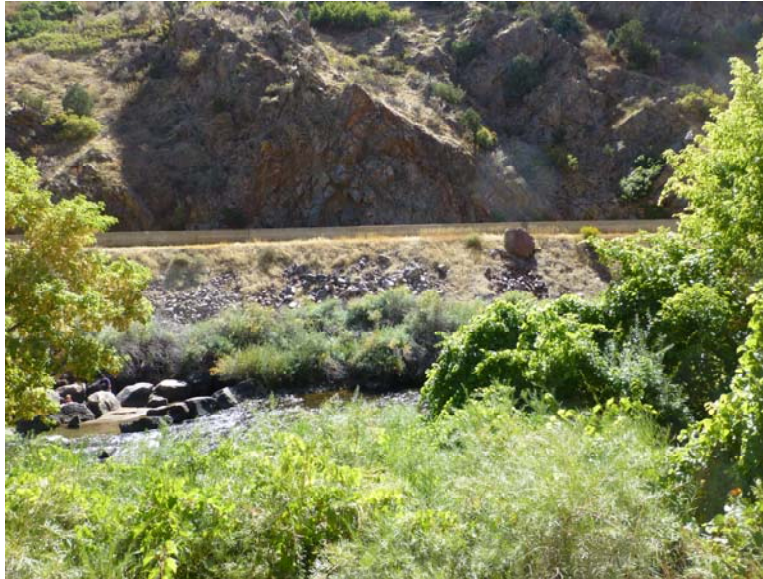
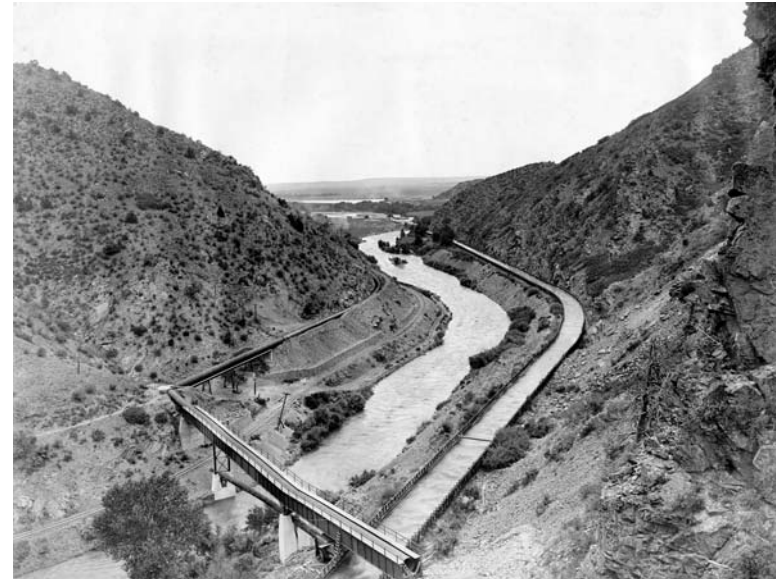
Ownership: Public, Denver Water
Additional Information: Originally wood; now concrete (top left photo). Historic photos (right top and bottom) courtesy of Denver Water, including top right photo from Album, 28, p 80, #1109, dated 07-29-12; and bottom right photo from Album 42, p. 66, #4779 dated 06-26-35.

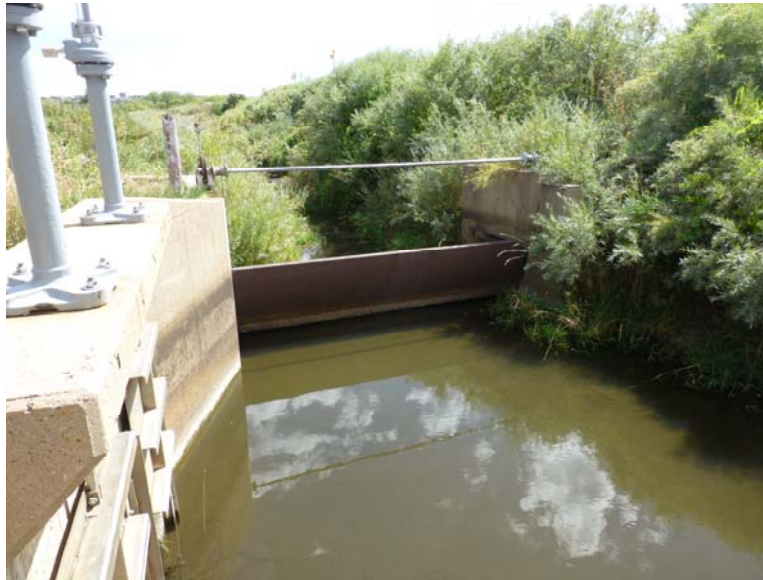
Site Number: bas_045_1; bas_045_3 **Map Index:** 1
Property Type: Structure—Diversion & Measurement; Gate
Description: Main Headgates from Canal to Reservoir
Significance: 4
Special Features: Original concrete mass but new stainless-steel diversion gates; pivoting Check Gate in main Canal to regulate downstream flow.

Ownership: Public, Denver Water
Additional Information: Parts of 1963 diversion group to fill Platte Canyon Reservoir from Canal, and control flow in Canal.

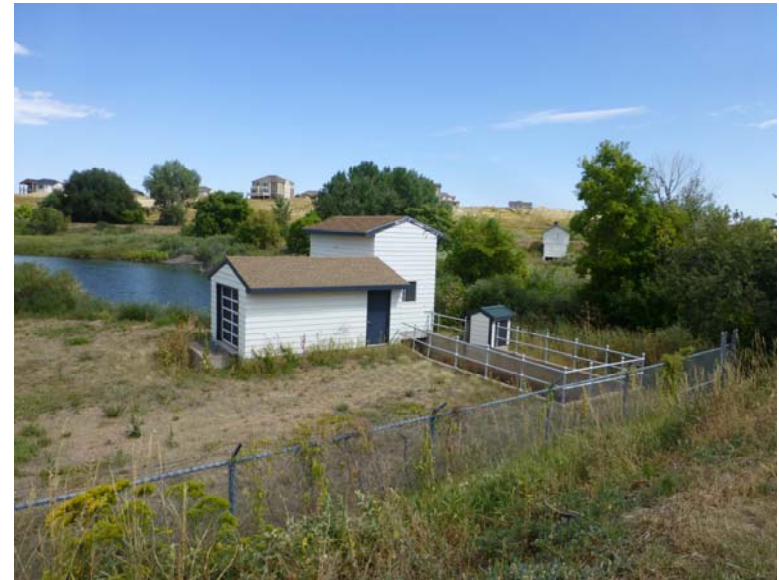
Site Number: bas_045_2 **Map Index:** 1
Property Type: Buildings—Canal Operation
Description: High Line Gauge House & Spillway
Significance: 4
Special Features: Channels are concrete with steel railings; Gauge House is wood-frame, synthetic siding, 1-story wing and 1 1/2-story wing that likely holds the gauging equipment.

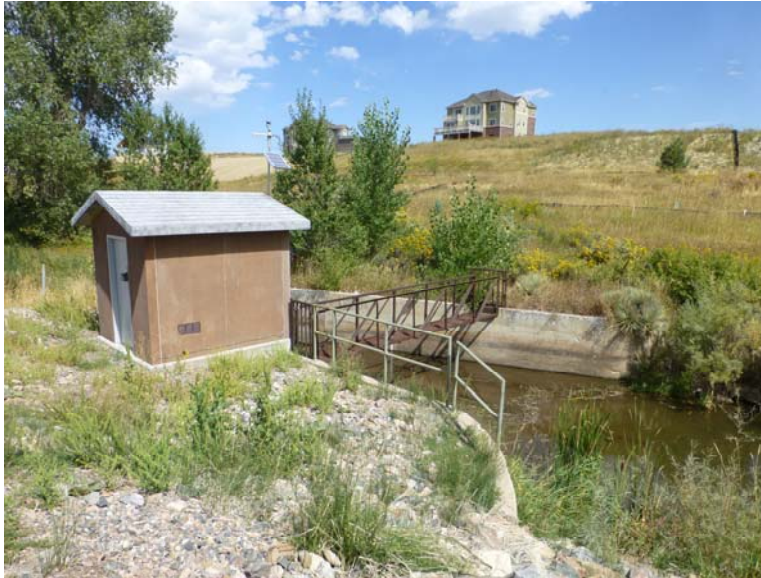
Site Number: bas_046_1 **Map Index:** 1
Property Type: Structure–Diversion: Turnout
Description: Headgate Remains
Significance: 4
Special Features: Concrete Gate abutments and metal Gate remnants.

Ownership: Public, Denver Water
Additional Information: Modern small building likely contains measuring equipment in current use.

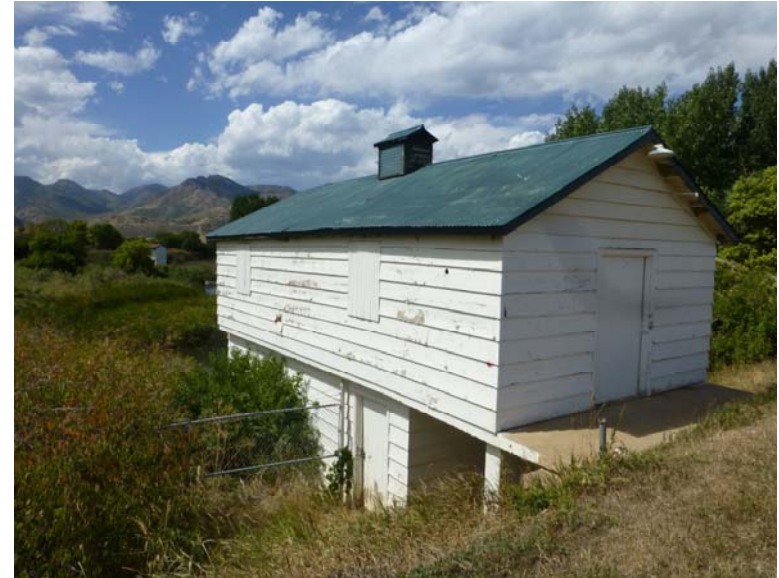
Site Number: bas_046_2 **Map Index:** 1
Property Type: Building–Canal Operation
Description: Alum/Gauge House, Spillway
Significance: 4
Special Features: Wood frame 2-story building with concrete main floor and stoop connecting door with Canal trail; lower level below Canal trail grade.

Ownership: Public, Denver Water
Additional Information: Building originally contained alum storage and application to treat water channeled into Reservoir.

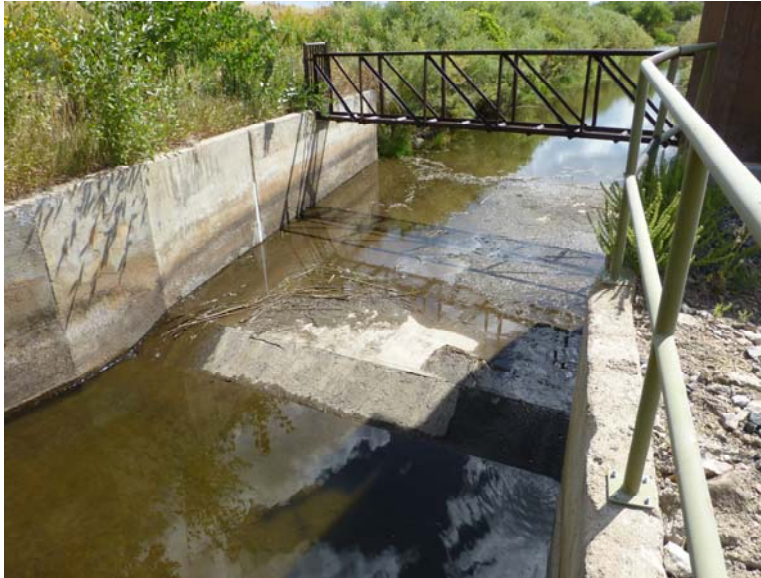
Site Number: bas_047_1 **Map Index:** 1
Property Type: Structure–Control & Measurement
Description: Parshall Measuring Flume and Drop
Significance: 4
Special Features: Constriction of Canal for standard measuring, and drop with concrete retaining walls. Modern shed and steel walkway across Canal.

Ownership: Public, Denver Water
Additional Information: Indentions in concrete sidewalls held measuring equipment.

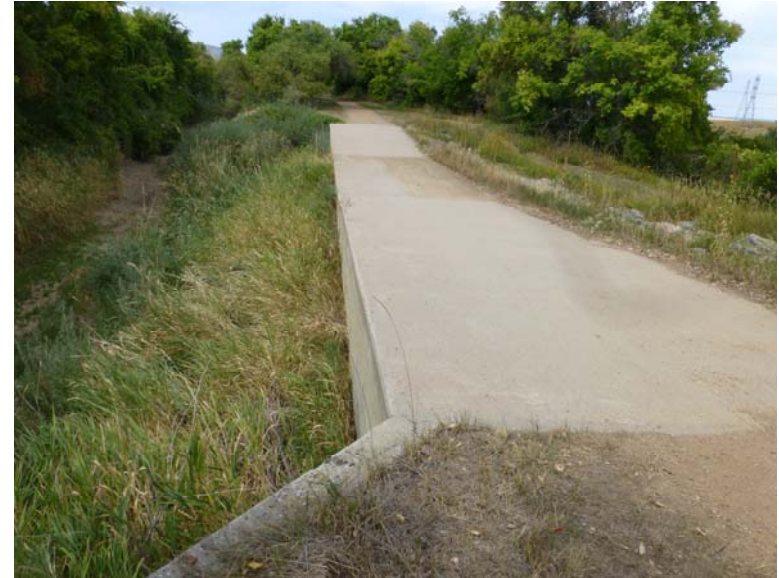
Site Number: bas_049_1; bas_049_2 **Map Index:** 1
Property Type: Structure–Protection & Cleaning: Wasteway
Description: Reinforced and Depressed Ditch Riders Trail
Significance: 3
Special Features: Concrete slab at trail grade.

Ownership: Public, Denver Water
Additional Information: Allows excess water in Canal to waste into adjacent creek.

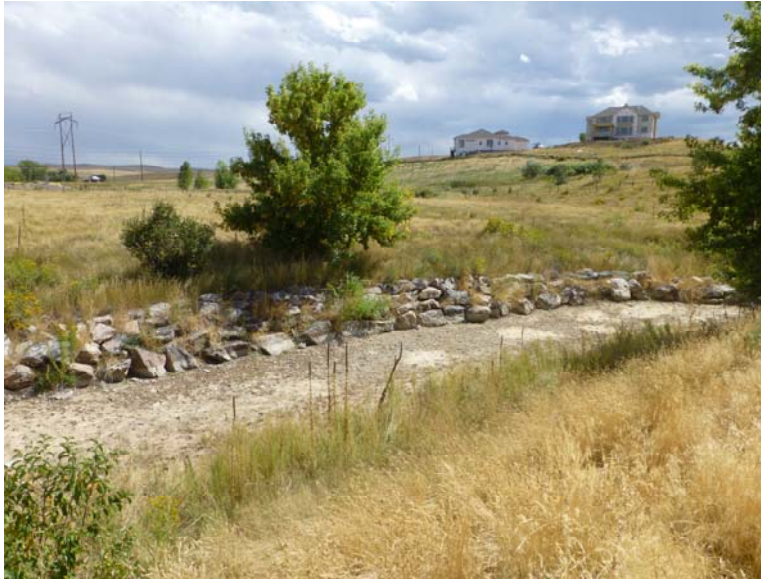
Site Number: bas_050_1; bas_050_2 **Map Index:** 1
Property Type: Structure–Protection & Cleaning
Description: Stone Rip Rap in Canal
Significance: 3
Special Features: Large stones lining hairpin turn of Canal

Ownership: Public, Denver Water
Additional Information: Protects outside Canal berms from erosion during high-velocity water flow, and undermining during water-delivery season.

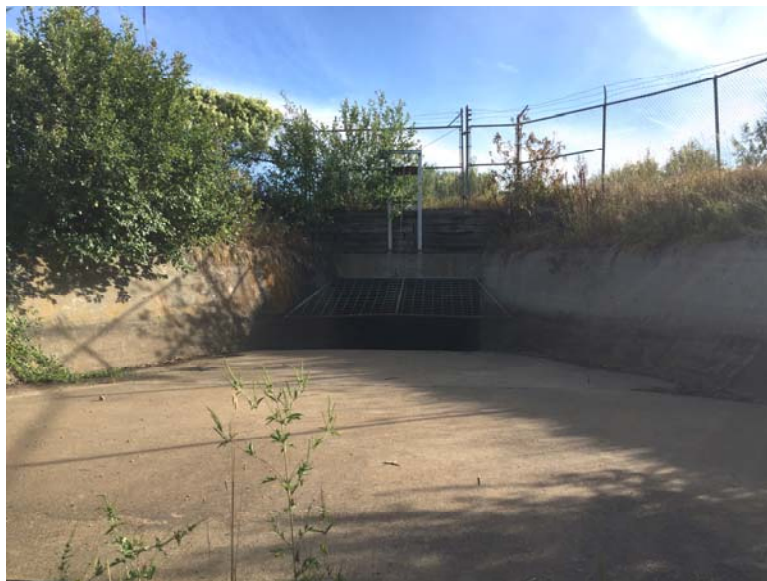
Site Number: bas_029_1; bas_029_2 **Map Index:** 2
Property Type: Structure–Conduit: Siphon
Description: Plum Creek Inverted Siphon, Inlet and Outlet
Significance: 4
Special Features: Concrete floor and sidewalls, steel grizzly at outlet.

Ownership: Public, Denver Water
Additional Information: Moves Canal water under Plum Creek. Outlet pictured; Inlet not accessible during Survey. A long concrete siphon replaced a wooden flume. At this location in 1966 (Source: Denver Water Photo Album 16A-286).

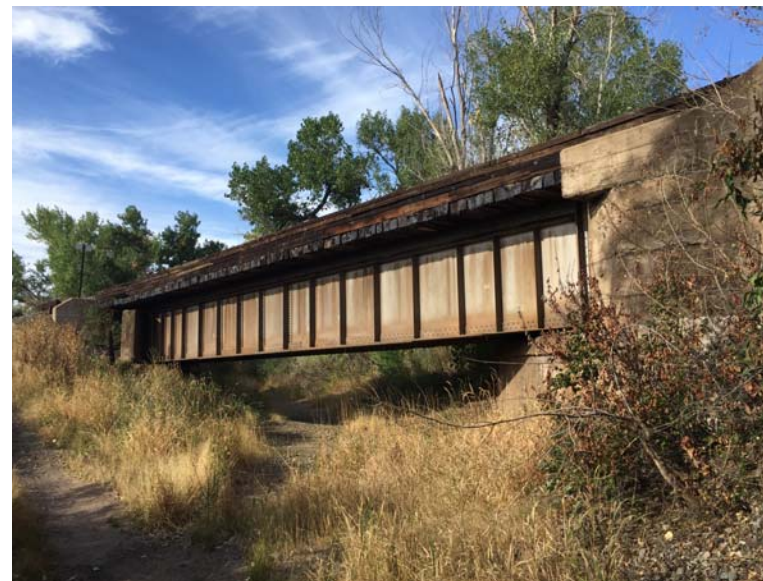
Site Number: bas_028_1 **Map Index:** 2
Property Type: Structure–Associated Railroad District
Description: Railroad Bridge over Canal
Significance: 4
Special Features: Steel Plate Deck Girder with Concrete Abutments.

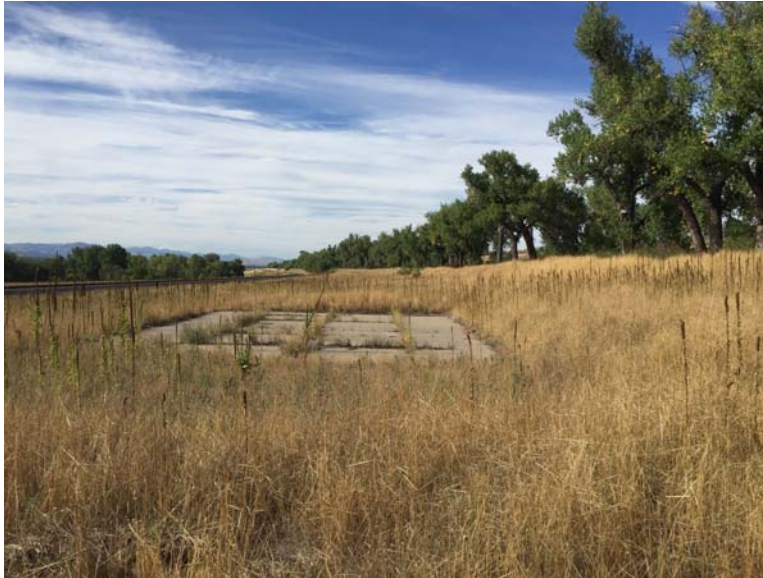
Site Number: 5DA.2336 **Map Index:** 2
Property Type: Other– Foundation
Description: Railroad Depot Building Foundation
Significance: 2
Special Features: Concrete slab. Associated trash dump nearby. Associated with associated railroad districts.

Ownership: Private
Additional Information: Long-abandoned railroad agency of Acequia station on the Denver & Rio Grande (now Union Pacific) Railroad (track at left—west—in photo, Canal at line of trees on right). *Acequia* is Spanish for irrigation canal.

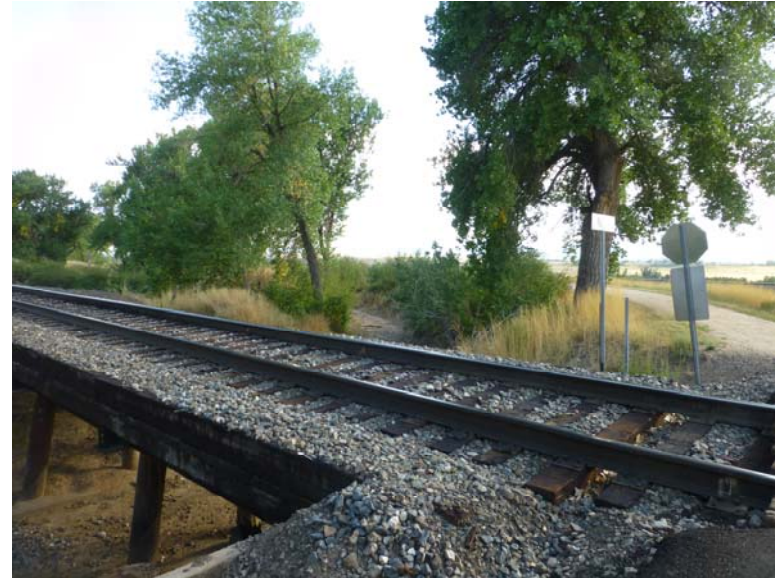
Site Number: bas_018_1 **Map Index:** 2
Property Type: Associated Structure– Access; Railroad District
Description: Railroad Bridge over Canal
Significance: 3
Special Features: Steel-pile railroad trestle, ballasted deck.

Ownership: Private
Additional Information: Atchison, Topeka & Santa Fe (now BNSF) Railway structure at the north end of a 2-mile segment of the Canal running between this track and the Denver & Rio Grande (now Union Pacific) Railroad track, all sharing a shelf above Plum Creek.

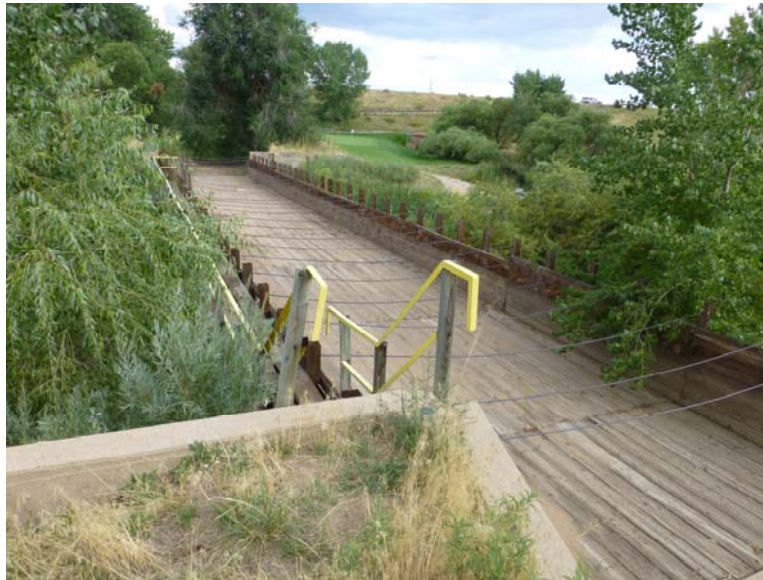
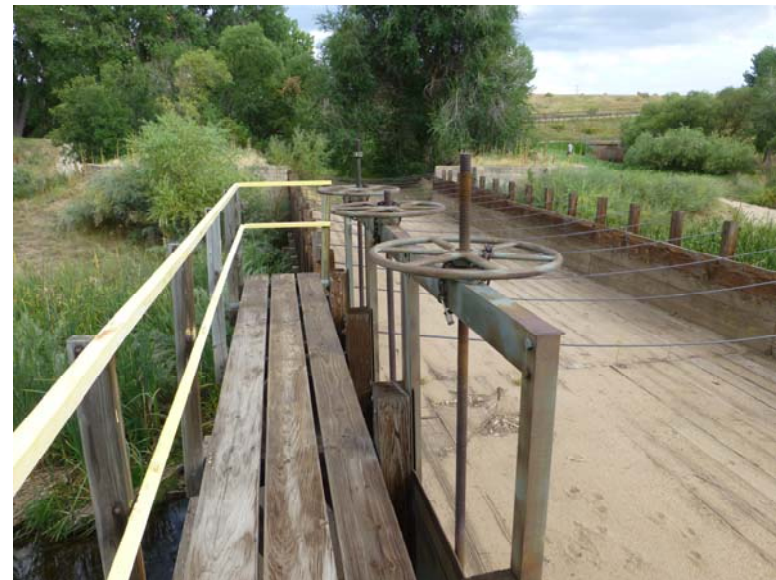
Site Number: bas_004_1 **Map Index:** 2

Property Type: Structure–Conduit: Flume

Additional Information: Gate allow wastewater to exit into Marcy Gulch. Concrete aprons on either end of flume and new concrete piers supporting flume date from Spring 1961. The timber components were replaced in 1968, and perhaps more recently also. (Source Photo Album 16A—286).

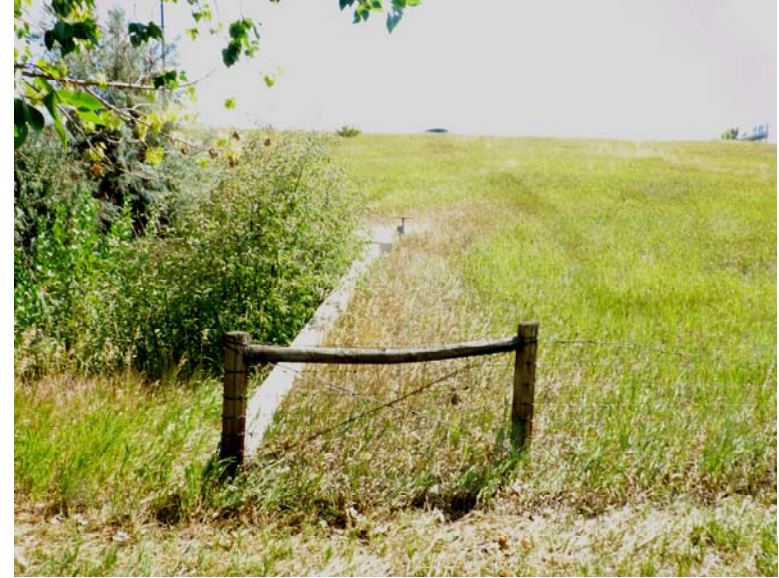
Site Number: bas_016_1 **Map Index:** 3
Property Type: Structure–Diversion: Turnout
Description: Plews Ranch, Gate 23
Significance: 2
Special Features: Steel Gate in Steel Tube, incorporated into new Concrete Culvert.

Ownership: Public, Denver Water
Additional Information: Probably location of original Gate 23 for Plews Ranch.

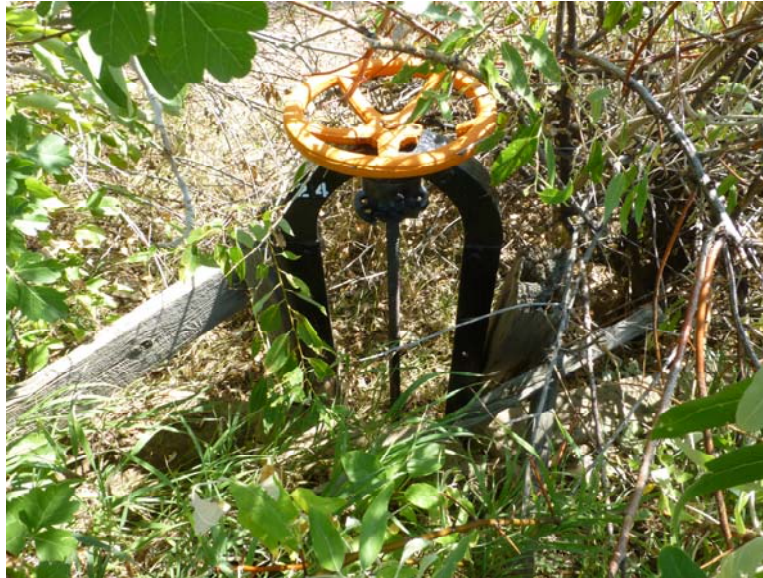
Site Number: bas_014_1 **Map Index:** 3
Property Type: Structure–Diversion: Turnout
Description: Gate 24
Significance: 4
Special Features: Steel Gate Frame with hand operated wheel raising screw shaft.

Ownership: Public, Denver Water
Additional Information: Heavily vegetated. Unknown if still operable.

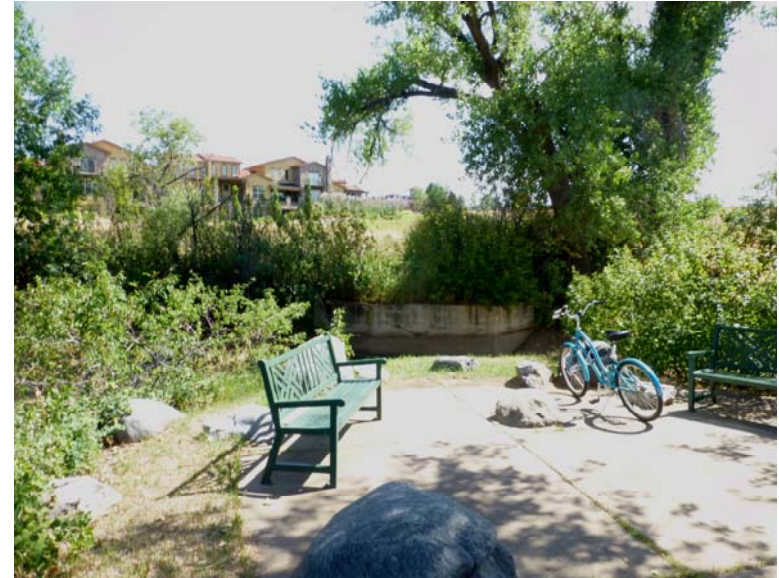
Site Number: bas_015_1 **Map Index:** 3
Property Type: Structure–Access
Description: Bridge Abutments
Significance: 3
Special Features: Concrete abutments and wing walls.

Ownership: Public, Denver Water
Additional Information: Bridge removed at unknown date. One abutment used for picnic area overlook of Canal (photo).

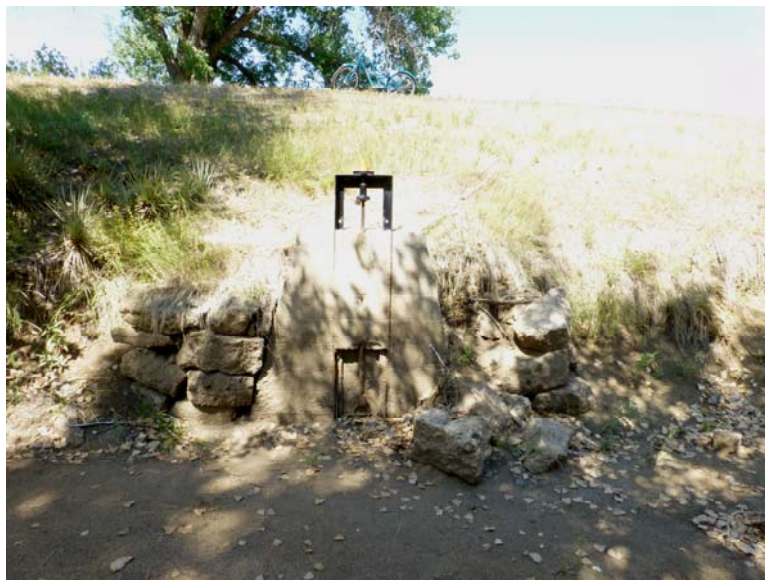
Site Number: bas_013_1 **Map Index:** 3
Property Type: Structure–Diversion: Turnout
Description: Gate 25
Significance: 4
Special Features: Concrete mass flanked by concrete-rubble riprap; steel frame for wheel and screw shaft.

Ownership: Public, Denver Water
Additional Information: Inoperable; passageway filled with concrete.

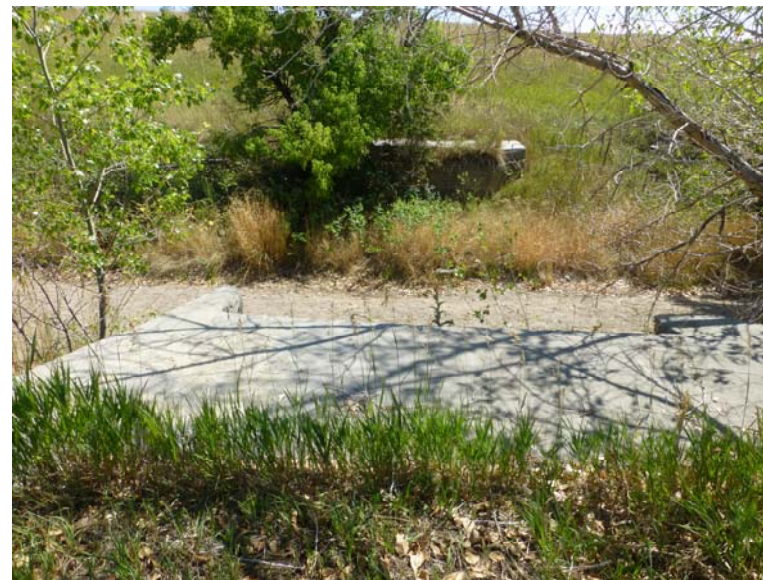
Site Number: bas_010_1 **Map Index:** 3
Property Type: Structure–Associated Access
Description: Bridge abutments
Significance: 3
Special Features: Concrete abutments for small (pedestrian?) bridge, flanking Canal.

Ownership: Public, Denver Water
Additional Information: Bridge removed at unknown date.

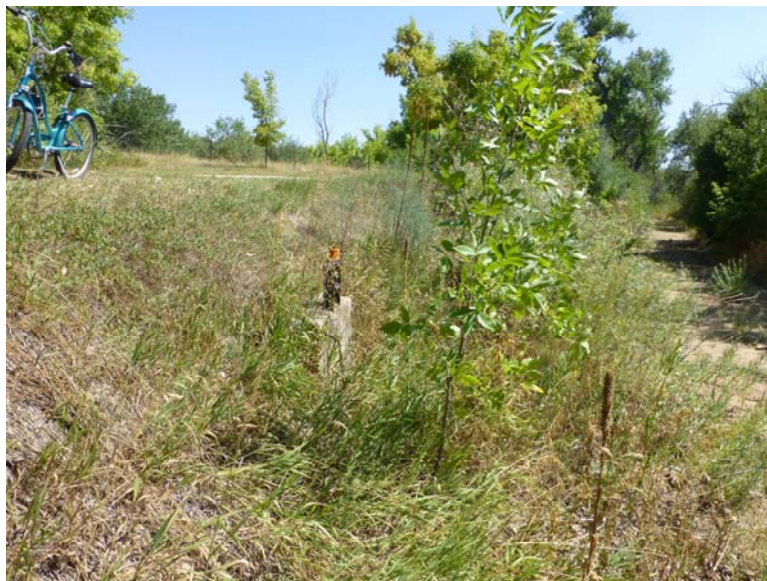
Site Number: bas_007_1 **Map Index:** 3
Property Type: Structure-Diversion: Turnout
Description: Gate 27
Significance: 4
Special Features: Concrete mass, Steel Gate Frame with hand operated wheel raising screw shaft.

Ownership: Public, Denver Water
Additional Information: Heavily vegetated. Unknown if still operable.

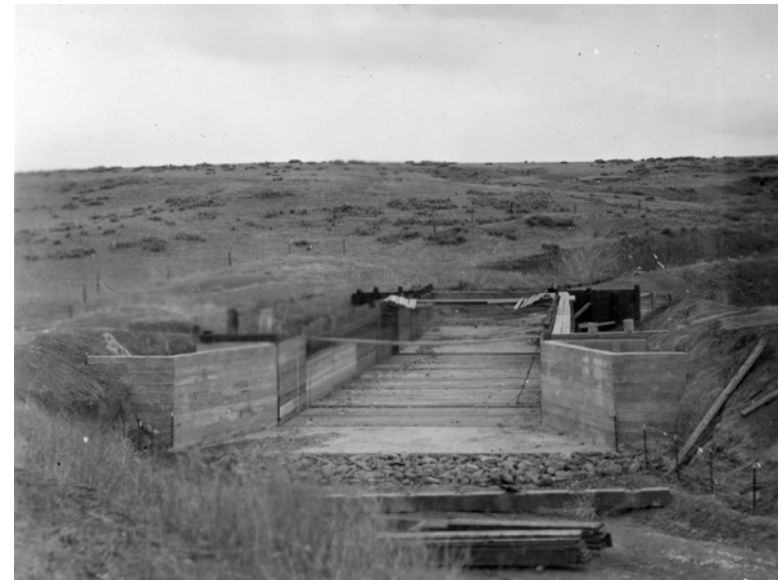
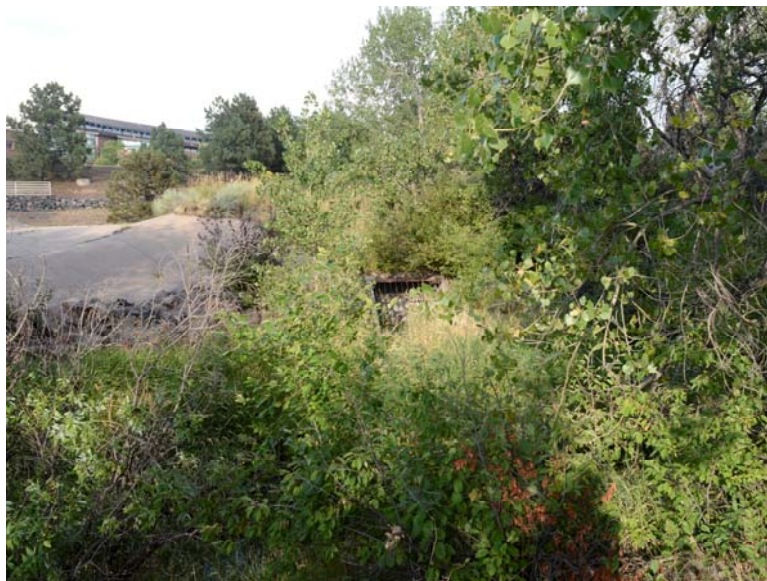
Additional Information: Dad Clark Gulch also referred to on maps as Bennett Gulch. Reconstructed in spring 1970 (Source: Denver Water Photo Album 16A-286). Historic photo at lower right courtesy of Denver Water, Album 41, P. 13, #4029, dated 03-02-35. Historic 1935 concrete retaining walls remain.

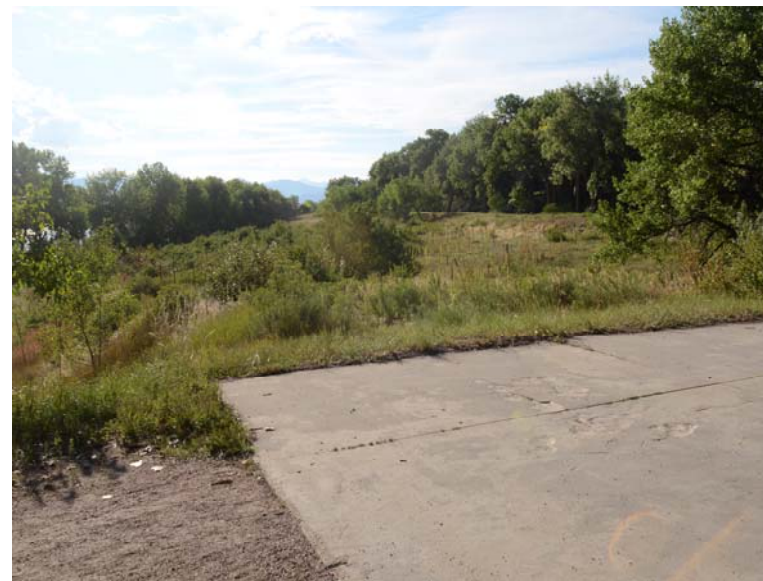
Site Number: cad_058_1 **Map Index:** 3
Property Type: Structure–Retention & Storage
Description: Spillway, McLellan Reservoir
Significance: 3
Special Features: Concrete Spillway and Channel at south end of Earthen Dam.

Ownership: Public, Denver Water
Additional Information: At Dam for McLellan Reservoir (see cad_057_1, McLellan Reservoir).

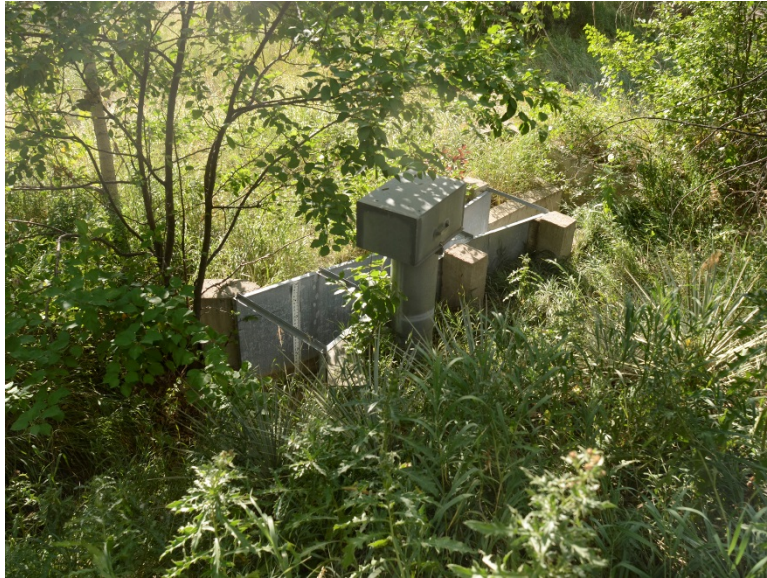
Site Number: cad_056_1 **Map Index:** 3
Property Type: Structure–Access Bridge Associated with Canal
Description: Former Roadway Bridge
Significance: 3
Special Features: Concrete Abutments on Canal, east of McLellan Reservoir.

Ownership: Public, Denver Water ROW
Additional Information: Abutments of a former road bridge and several slabs of crowned concrete road on both sides. A recreational bridge was built using the abutments. Original bridge may have been a truss, and perhaps a railroad bridge. A crowned grade descends to the west, now cut off by Reservoir.

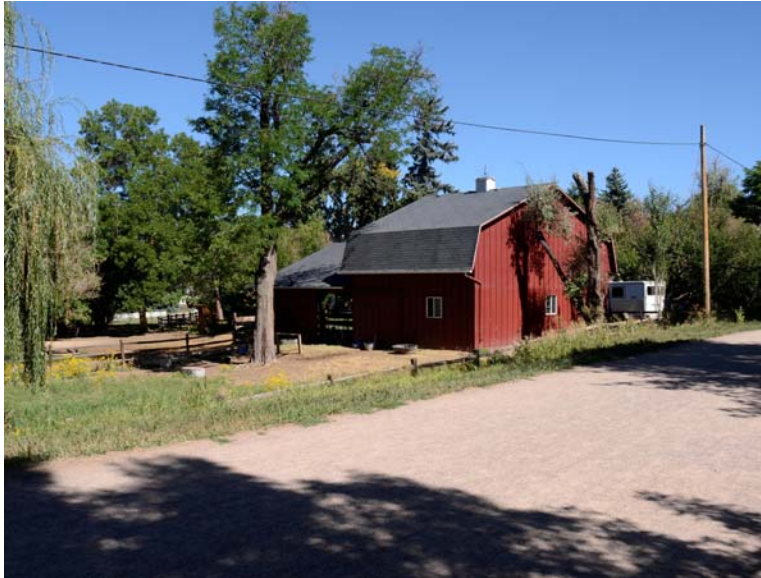
Site Number: cad_060_1 **Map Index:** 3
Property Type: Building–Associated with Canal
Description: Gambrel-Roof Barn, Pond
Significance: 3
Special Features: Wood-frame Building with modern board-and-batten siding, replacement windows.

Ownership: Private
Additional Information: In good condition if altered; survivor of agricultural uses of Canal. Adjacent Pond.
