RECONNAISSANCE SURVEY AND PRIORITIZED SURVEY PLAN: HIGH LINE CANAL CORRIDOR

Written and published for the High Line Canal Conservancy

Square Moon Consultants, Inc.

©High Line Canal Conservancy—October 2016

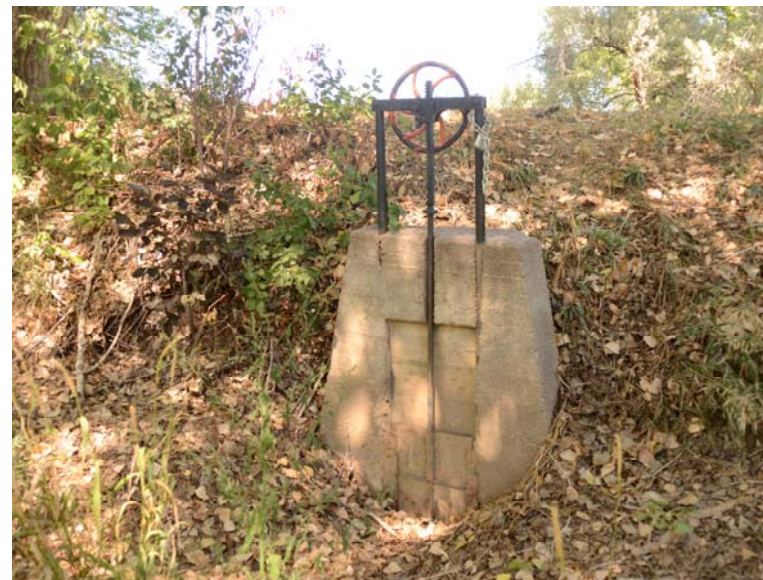
Site Number: cad_062_1 **Map Index:** 3
Property Type: Structure–Diversion: Turnout
Description: Gate 36
Significance: 4
Special Features: Concrete Mass, Steel Frame supporting vertical-mount hand operated Wheel, screw shaft partly in, partly out of the concrete stand.

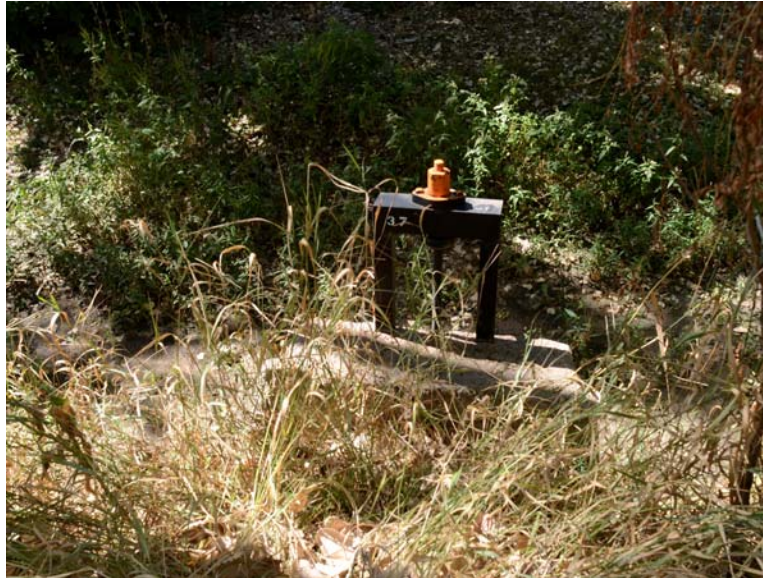
Site Number: cad_063_1 **Map Index:** 3
Property Type: Structure–Diversion: Turnout
Description: Gate 37
Significance: 4
Special Features: Concrete mass, with steel frame for screw shaft; wheel removed.

Ownership: Public, Denver Water
Additional Information: Date of 9/18/44 scribed into the concrete Gate mass. Appears in good condition; operable?

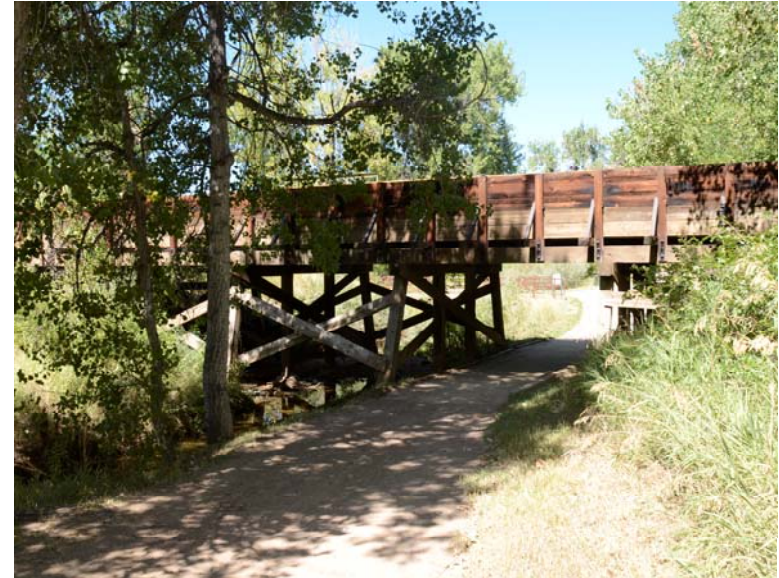
Site Number: cad_064_1 **Map Index:** 3
Property Type: Structure–Conduit
Description: Cheese Factory (or Lee Gulch) Flume
Significance: 4
Special Features: Wood Flume on wood Trestle. One of 3 surviving flumes, and only one still on timber trestle supports.

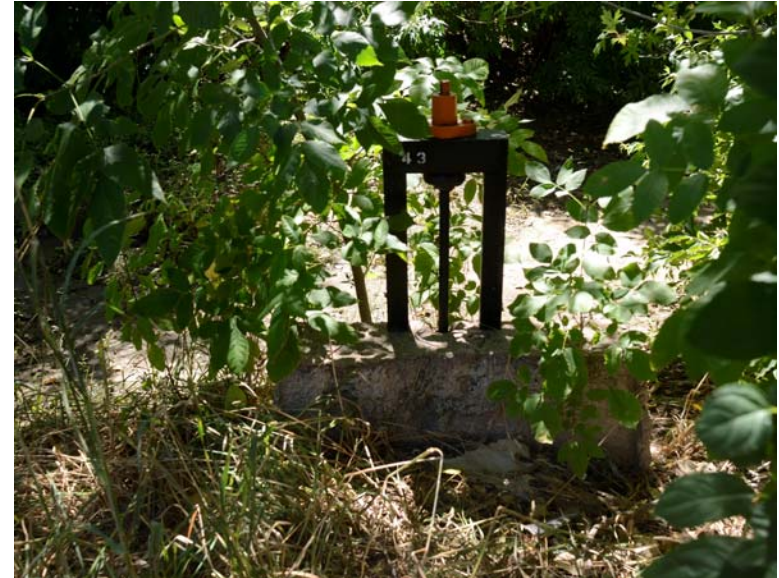
Site Number: cad_065_1 **Map Index:** 3
Property Type: Structure–Diversion: Turnout
Description: Gate 39
Significance: 4
Special Features: Concrete mass, with steel frame for screw shaft; wheel removed.

Ownership: Public, Denver Water
Additional Information: Date in concrete: 1-21-43.
Decommissioned.

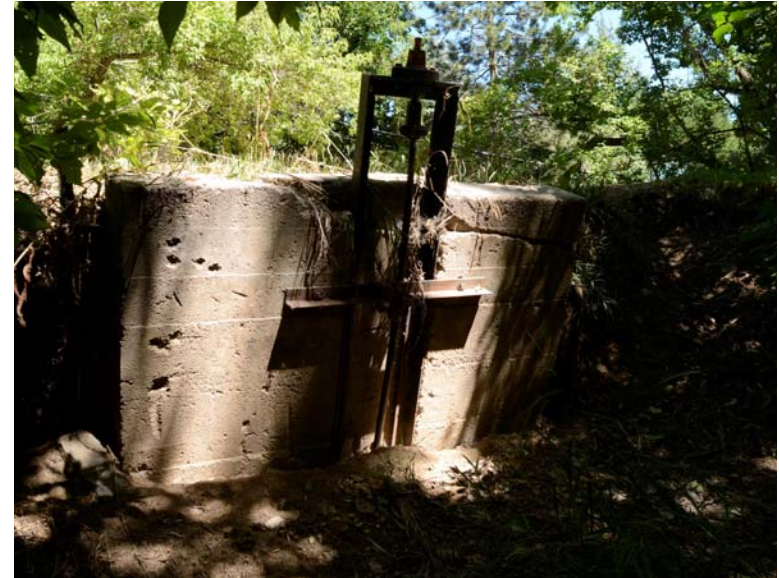
Site Number: cad_069_1 **Map Index:** 4
Property Type: Structure–Diversion: Turnout
Description: Gate 48
Significance: 4
Special Features: Concrete mass, with steel frame for screw shaft; wheel removed.

Ownership: Public, Denver Water
Additional Information: Gate buried in silt. Decommissioned.

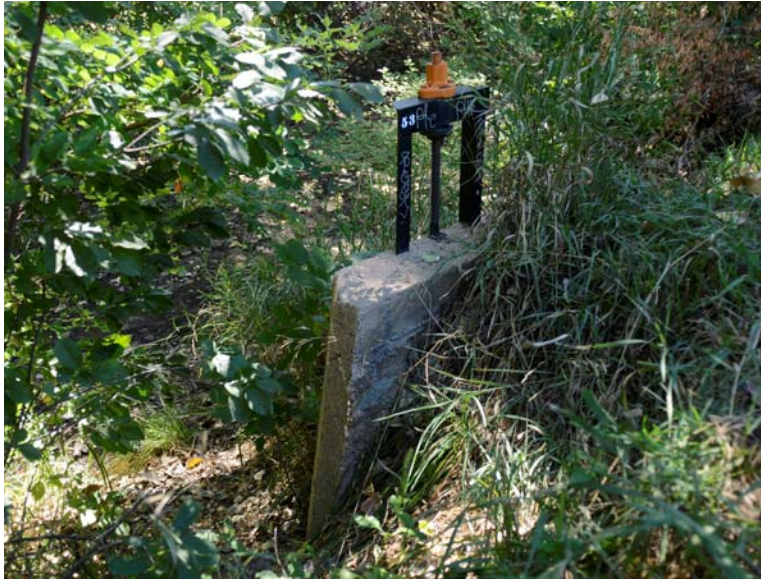
Site Number: cad_071_1 **Map Index:** 4
Property Type: Structure–Diversion: Turnout
Description: Gate No. ?
Significance: 4
Special Features: Concrete mass, with steel frame for screw shaft; wheel removed.

Ownership: Public, Denver Water
Additional Information: Gate buried in silt. Apparently decommissioned.

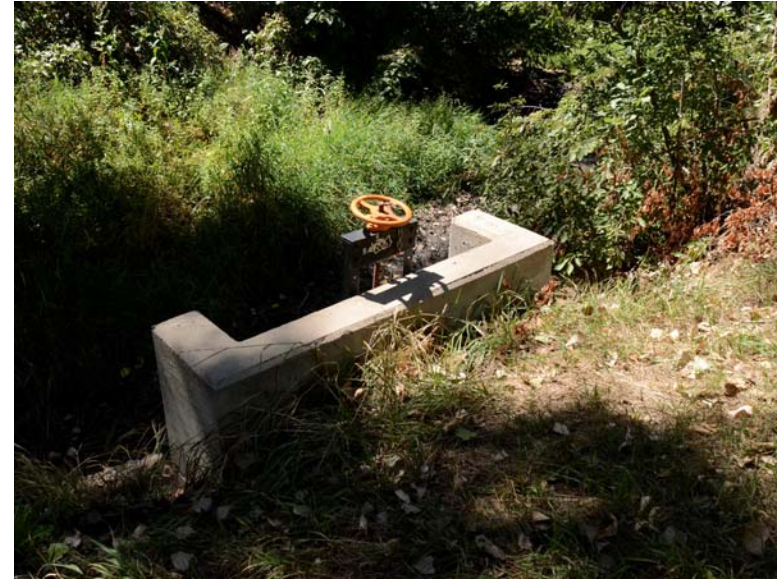
Site Number: cad_072_1; cad_073_1 **Map Index:** 4
Property Type: Structure–Diversion: Turnout
Description: Gate 53, and Gate 53-0200
Significance: 4
Special Features: Each: concrete mass, with steel frame for screw shaft; wheel removed.

Ownership: Public, Denver Water
Additional Information: Date in Gate 53 concrete: 8/12/40. Both decommissioned.

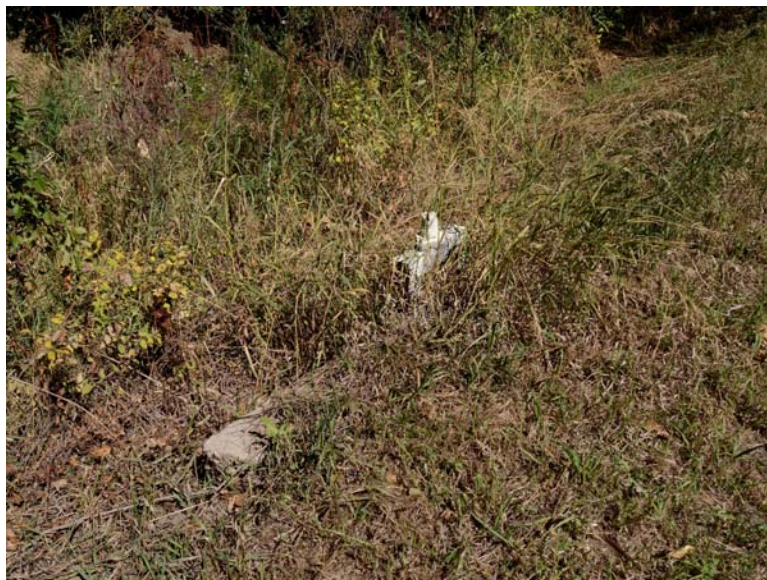
Site Number: cad_074_1 **Map Index:** 4
Property Type: Structure–Diversion: Turnout
Description: Gate 54
Significance: 4
Special Features: Concrete mass, with steel frame for screw shaft; wheel removed.

Ownership: Public, Denver Water
Additional Information: Still in use. Date in abutment concrete: 4-10-96.

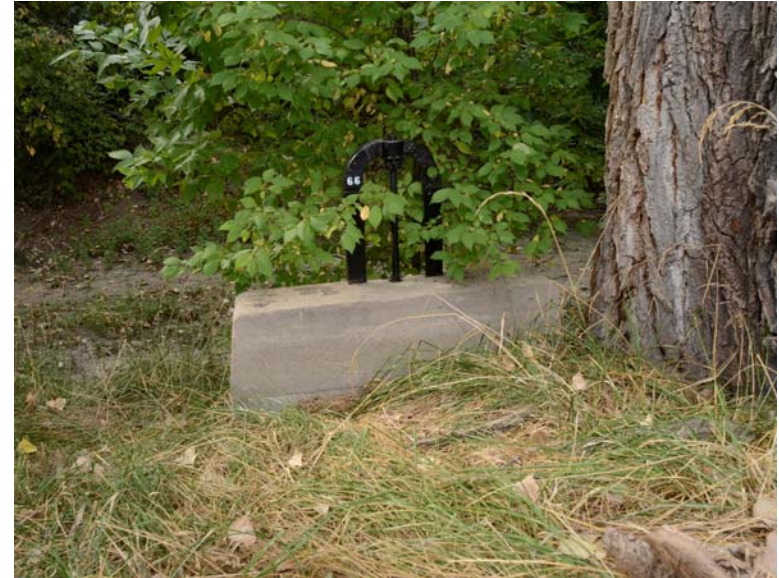
Site Number: cad_092_1 **Map Index:** 4
Property Type: Structure–Diversion: Turnout
Description: Gate 66
Significance: 4
Special Features: Concrete Mass, Steel Frame. Wheel missing from screw shaft in concrete.

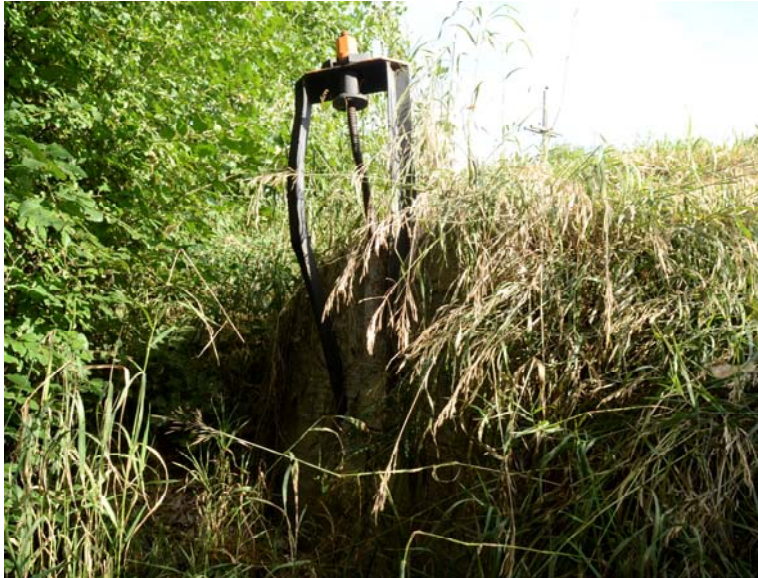
Site Number: cad_028_1 **Map Index:** 5
Property Type: Structure-Diversion: Turnout
Description: Gate No. 90
Significance: 4
Special Features: Concrete Mass, Steel Gate Frame

Ownership: Public, Denver Water
Additional Information: Heavily damaged, but enough material evident to identify it as a historic gate.

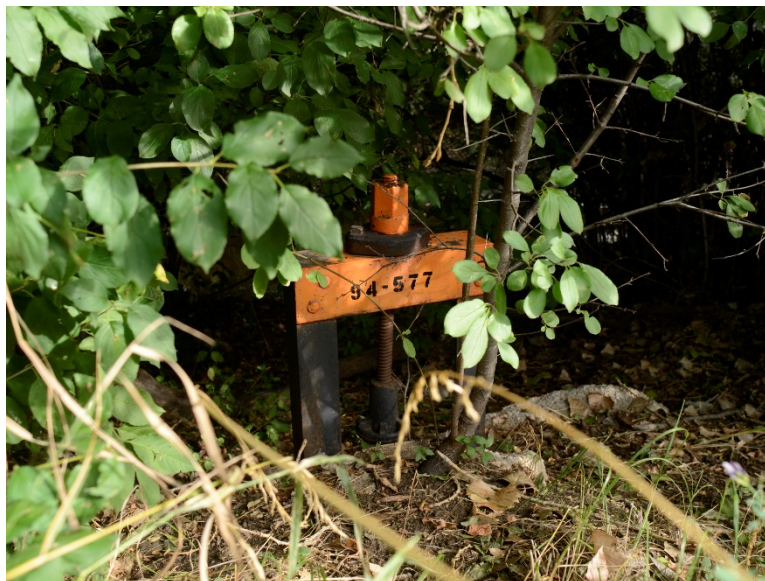
Site Number: cad_027_1; cad_026_1 **Map Index:** 5
Property Type: Structure–Diversion: Turnout
Description: Gate No 94 - 341, and Gate No. 94 - 577
Significance: 4
Special Features: Concrete Mass and Steel Gate Frame.

Ownership: Public, Denver Water
Additional Information: This condition also applied to cad_017_1, heavily silted, and both decommissioned.

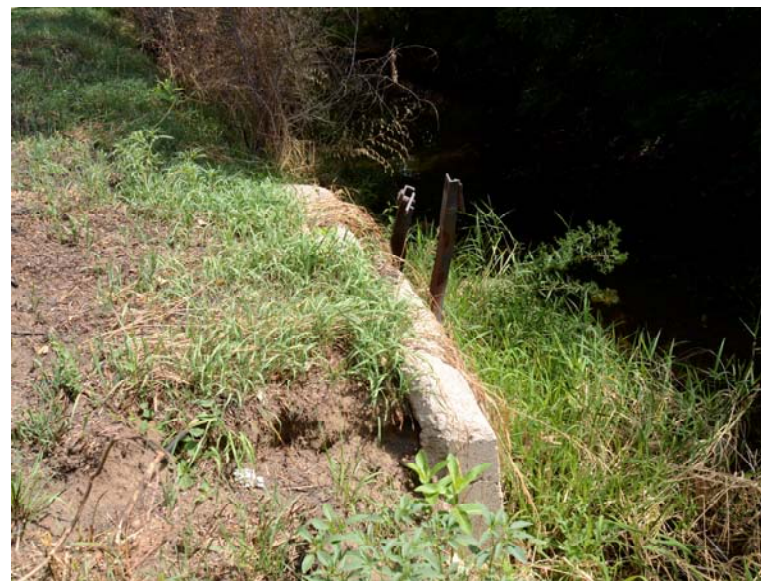
Site Number: cad_014_1; cad_010_1 **Map Index:** 5
Property Type: Structure–Diversion: Turnout
Description:
Significance: 4
Special Features: Concrete Mass and Steel Gate Frame

Ownership: Public, Denver Water
Additional Information: Missing Wheel and Screw Shaft. Cad_010 is on Map Index sheet 6.

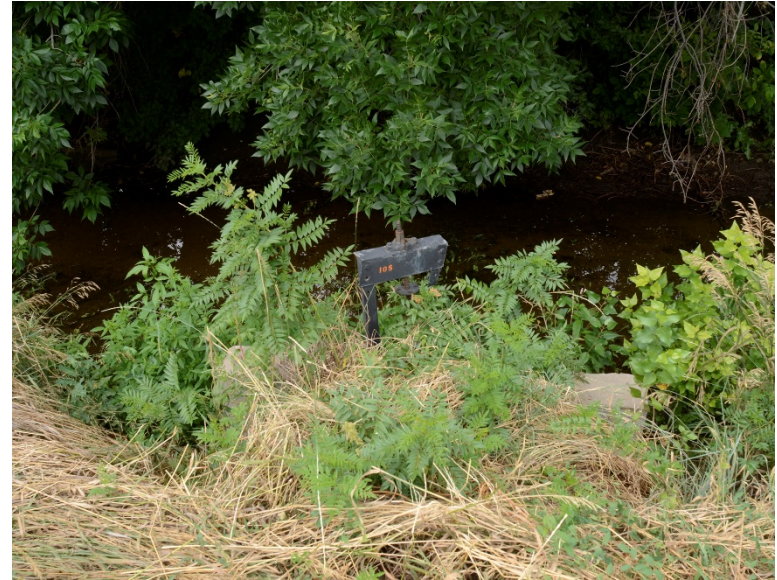
Site Number: cad_008_1 **Map Index:** 6
Property Type: Structure—Headgate & Diversion
Description: Gate No. 105
Significance: 4
Special Features: Concrete Mass, Steel Gate Frame

Ownership: Public, Denver Water
Additional Information: Decommissioned, deteriorated, concrete abutment with metal superstructure, missing wheel and much of rod (cut off). Still has base and metal superstructure evident.

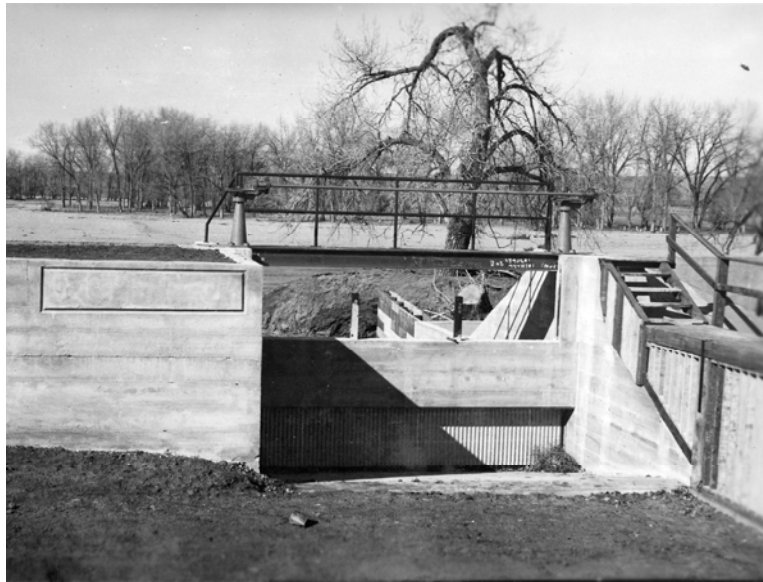
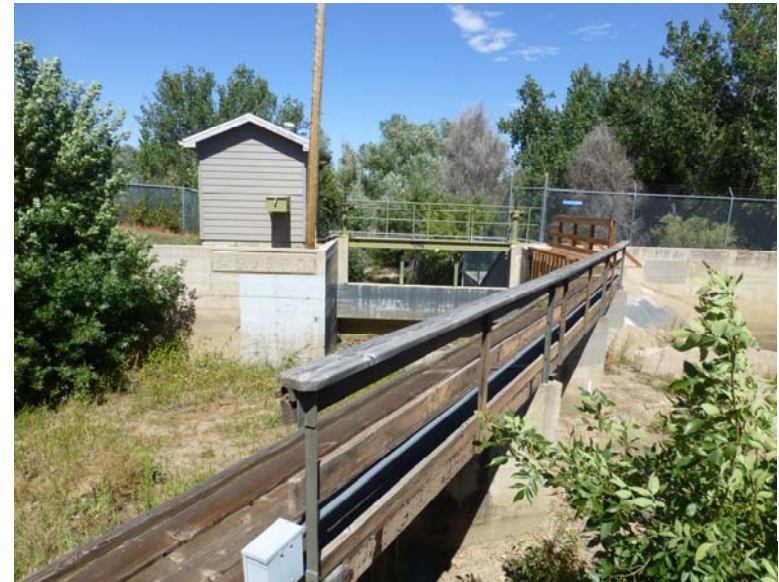
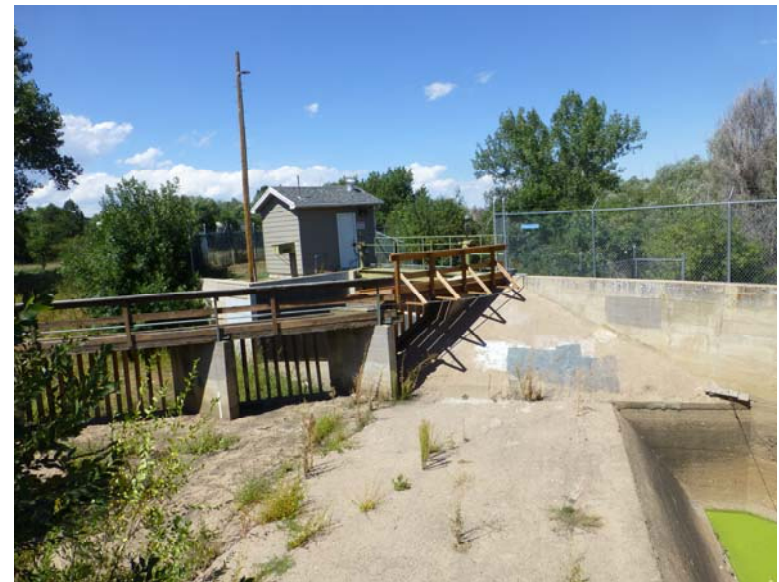
Additional Information: Made of concrete of various ages indicating repairs/additions. Chain link fence on top. Related to cad-002, Siphon Inlet

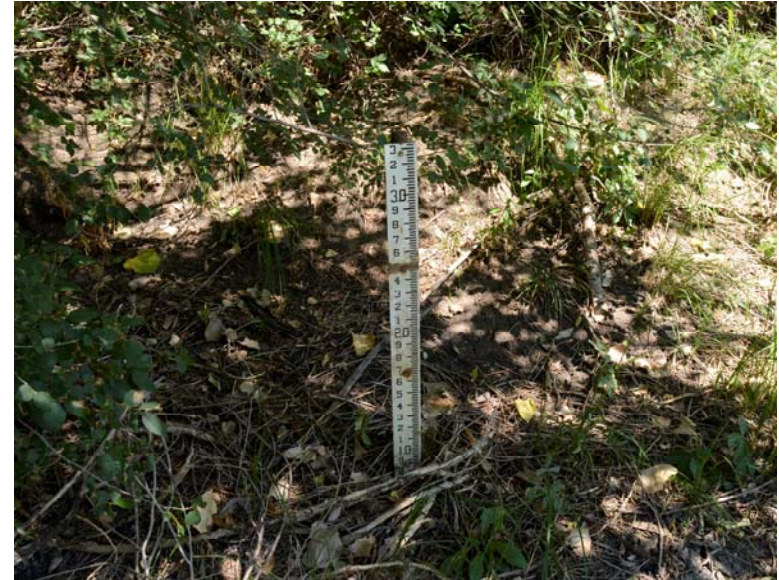
Site Number: cad_034_1 **Map Index:** 6
Property Type: Structure–Control & Measurement
Description: Measurement Device
Significance: 3
Special Features: Steel Measuring Rod with Black Numbers (Porcelain Enamel?)

Ownership: Public, Denver Water
Additional Information: On northeast bank. Almost completely buried (up to 7 inches). Likely just for measuring level.

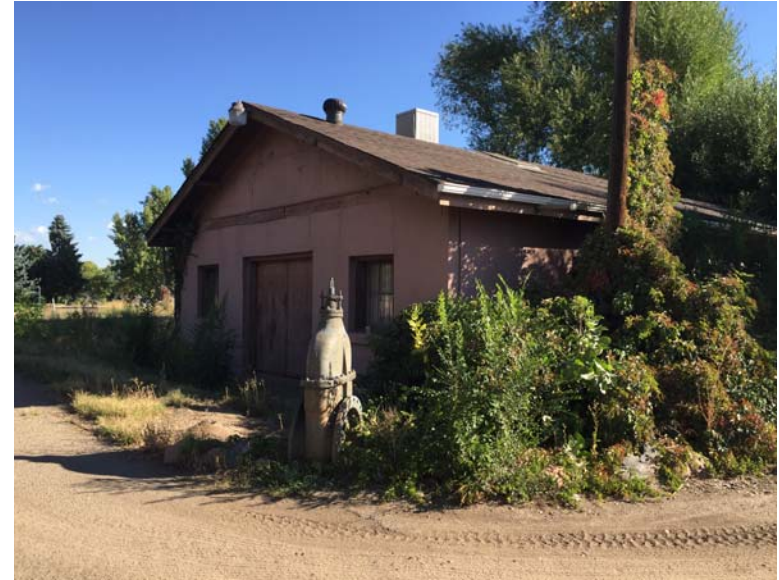
Site Number: cad_036_1 **Map Index:** 6
Property Type: Building, Structure–Control & Measurement
Description: Fairmount Cemetery Water Infrastructure
Significance: 4
Special Features: Numerous metal pipes, discarded large valve, and front gabled stucco building that probably contains pumping or water distribution equipment

Ownership:
Additional Information: Fairmont Cemetery water infrastructure for drawing water from Canal.

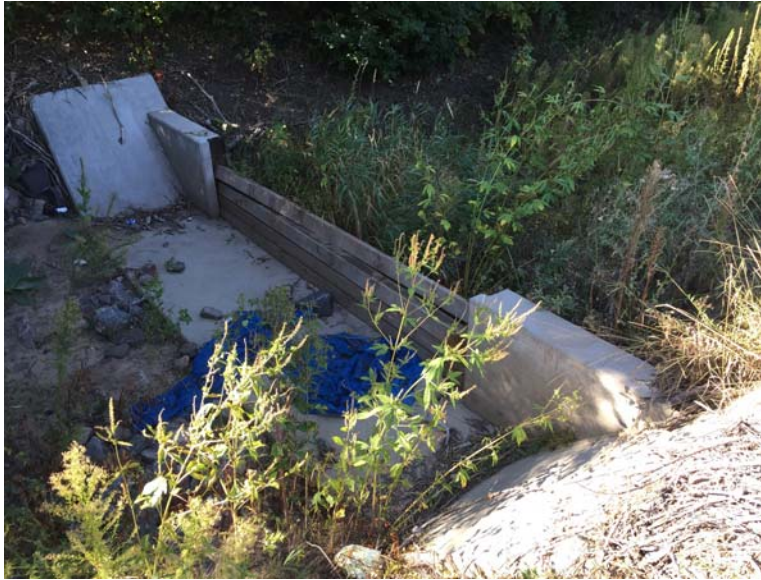
Site Number:	cad_036_2	Map Index:	6
Property Type:	Structure–Control & Measurement		
Description:	Fairmount Cemetery Check Dam		
Significance:	4		
Special Features:	Concrete base and Gate Slots; Removable Wood Slats for Variable Dam Height		
Ownership:	Public, Denver Water		
Additional Information:	Part of Fairmount Cemetery water infrastructure for drawing water from Canal.

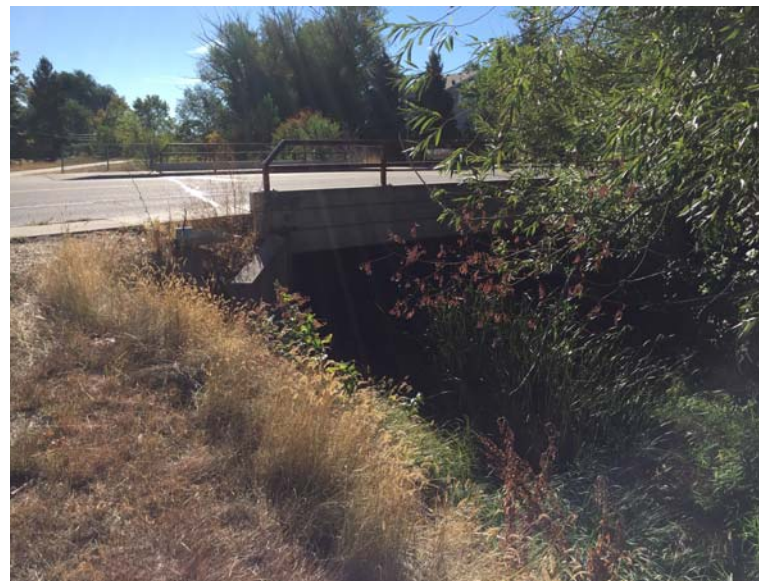
Site Number: bas_021_1 **Map Index:** 7
Property Type: Structure–Diversion: Turnout
Description: Headgate to Sand Creek Lateral
Significance: 4
Special Features: Steel Gate, Wheel and Screw Shaft

Ownership: Public, Denver Water
Additional Information: Incorporated into South Peoria Street Bridge's Wingwall (foreground in Photo) in Aurora.

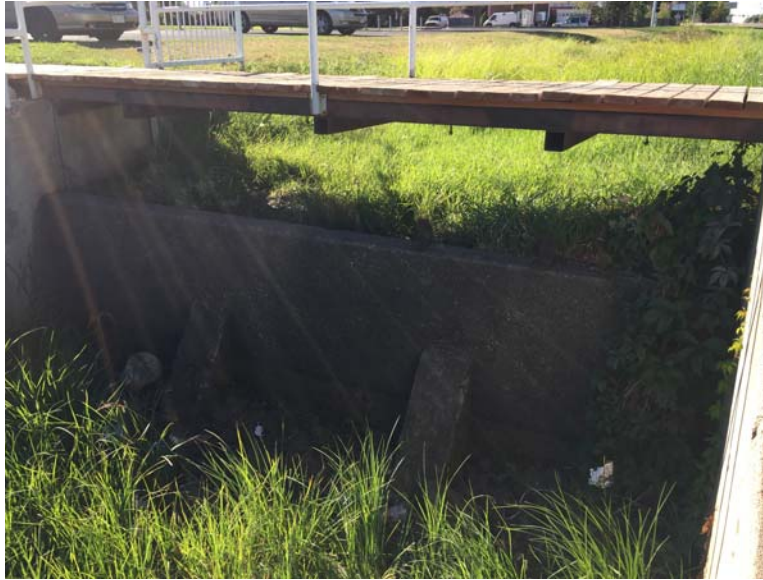
Site Number: bas_022_1 **Map Index:** 7
Property Type: Structure–Control & Measurement
Description: Del Mar Park Check Dam
Significance: 4
Special Features: Concrete Wingwalls and Slab with downstream Integral Buttresses.

Ownership: Public, Denver Water
Additional Information: Footbridge uses Wingwalls as abutments. Well maintained. Deep silt on upstream side.

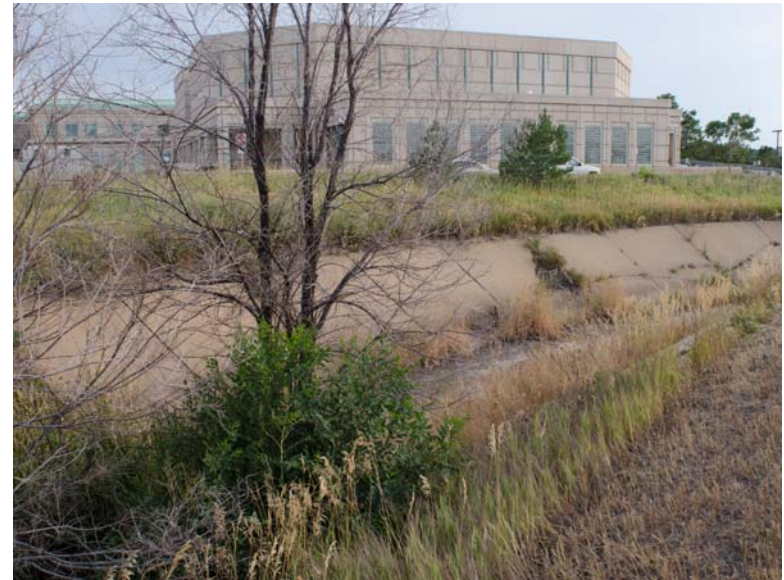
Site Number: cad_037_1; cad_037_2 **Map Index:** 7
Property Type: Structure–District: Canal
Description: Rebuilt Canal in Aurora
Significance: 4
Special Features: Concrete-lined Culvert

Ownership: Public, Denver Water
Additional Information: Rebuilt at unknown date, but likely following flood damage in 1960s.

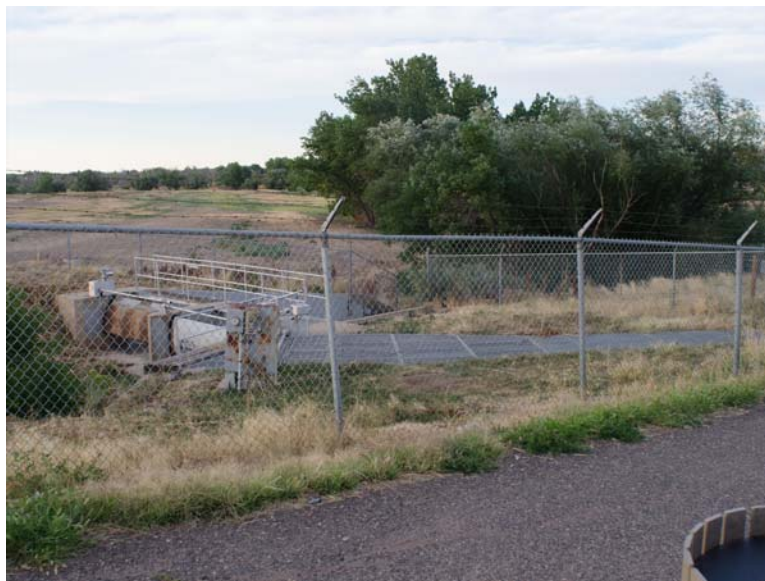
Site Number: cad_038_1; cad_038_2 **Map Index:** 7
Property Type: Structure–Conduit: Siphon
Description: West Toll Gate Creek Inverted Siphon
Significance: 4
Special Features: Concrete Mass and Steel Grizzly (left foreground in photo) protecting Siphon Inlet; Steel pivoting Wasteway Gates (left background in photo)

Ownership: Public, Denver Water
Additional Information: Inlet and Outlet, likely modern, appear to be well maintained. USGA maps mark as Toll Gate Creek Inverted Siphon. Two pivoting Wasteway Gates appear to have remotely controlled electric motors. Chain-link fence protects this infrastructure.

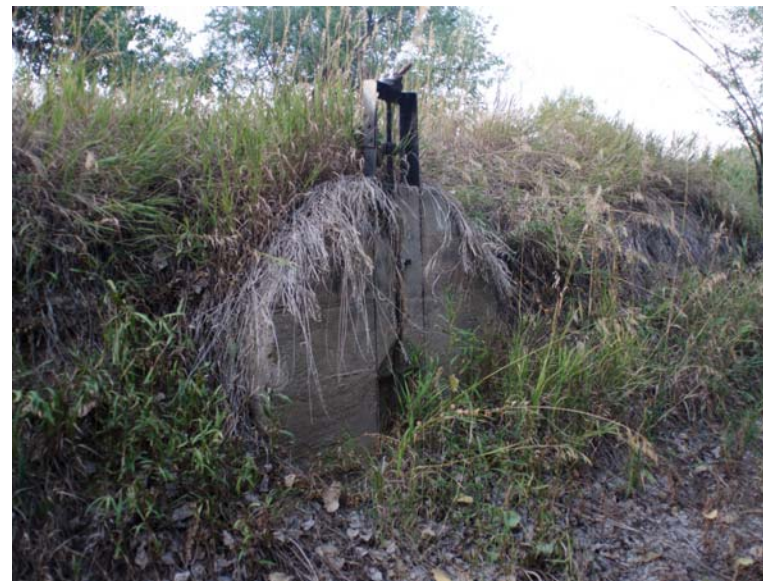
Site Number: cad_039_1 **Map Index:** 7
Property Type: Structure–Diversion: Turnout
Description: Gate No. ?
Significance: 4
Special Features: Broken Concrete Mass and Steel Gate

Ownership: Public, Denver Water
Additional Information: Decommissioned gate similar to others documented. Wheel missing from Screw Shaft.

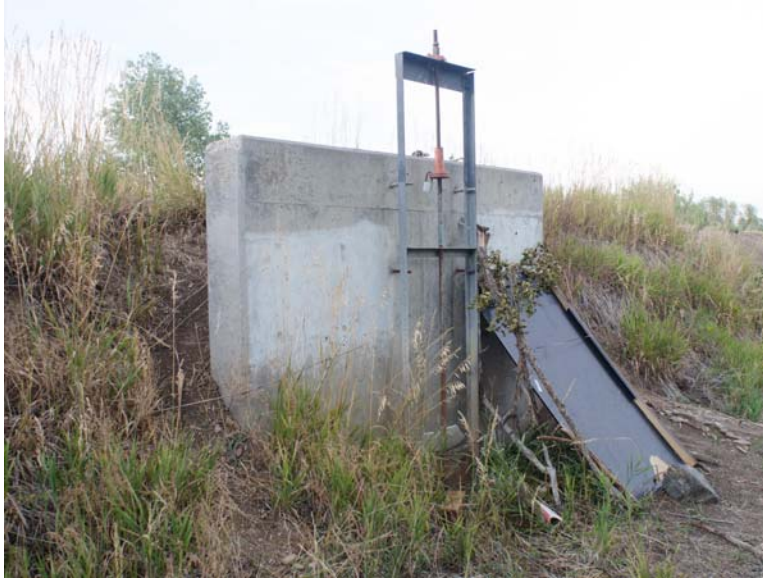
Site Number: cad_040_1 **Map Index:** 7
Property Type: Structure–Diversion, Turnout
Description: Gate 130
Significance: 4
Special Features: Concrete Mass, Steel Gate and Frame

Ownership: Public, Denver Water
Additional Information: Appears recently rebuilt, but decommissioned.
 Wheel missing from Screw Shaft.

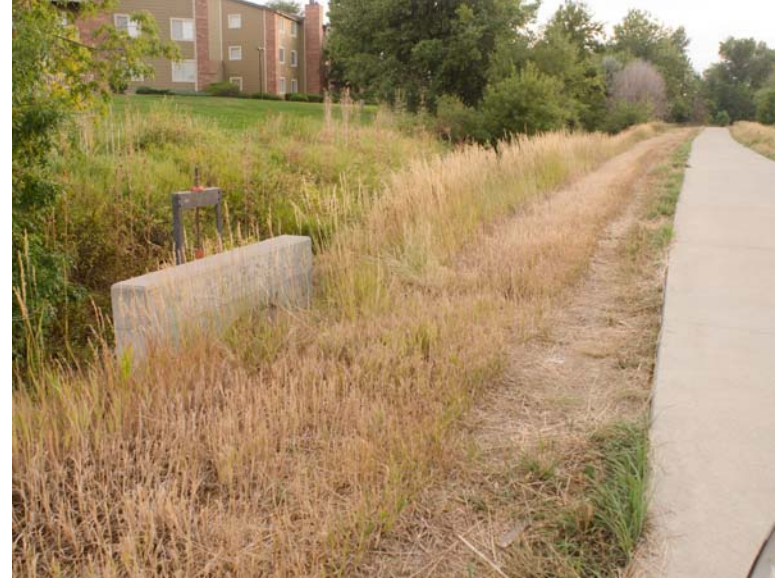
Site Number: cad_040_2 **Map Index:** 7
Property Type: Structure–Diversion, Turnout
Description: Gate 130 - 514 [?]
Significance: 4
Special Features: Concrete Mass, Steel Gate and Frame

Ownership: Public, Denver Water
Additional Information: Appears recently rebuilt, but decommissioned.
 Wheel missing from Screw Shaft.

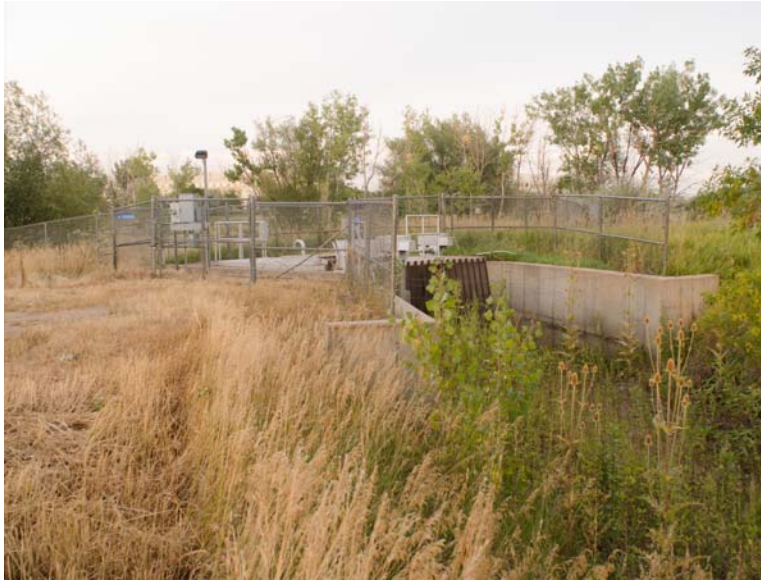
Site Number: cad_041_1; cad_041_2 **Map Index:** 7
Property Type: Structure–Conduit: Siphon
Description: East Toll Gate Creek Inverted Siphon
Significance: 4
Special Features: Concrete Mass and Steel Grizzly protecting Siphon Inlet.

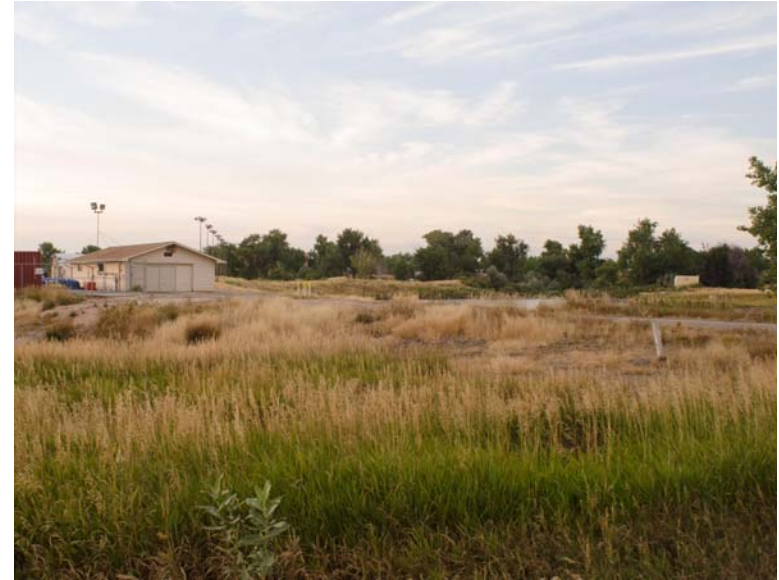
Site Number: cad_042_1 **Map Index:** 7
Property Type: Structure–Storage & Retention
Description: Centre Hills Pond and Pump Station
Significance: 3
Special Features: Storage Pond and Pumphouse for Centre Hills Golf Course.

Ownership: Public, City of Aurora
Additional Information: Pond is in middle distance (photo), Pump Station is small building at right distance.

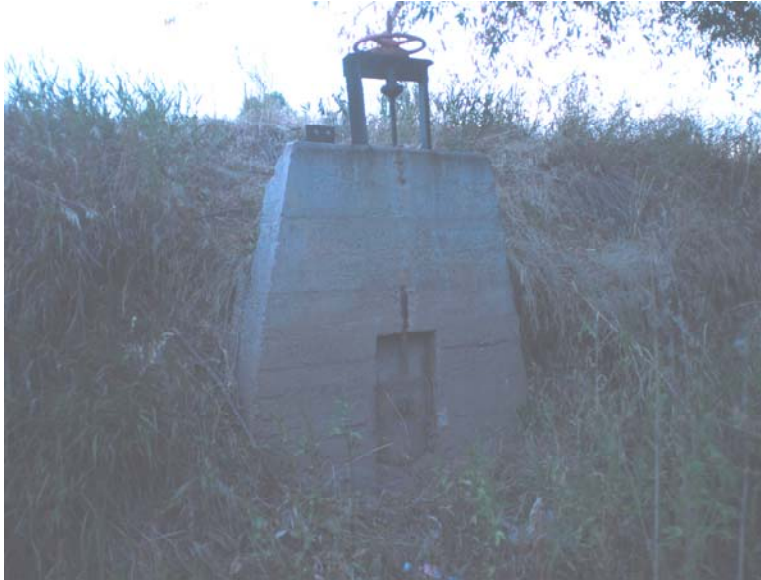
Site Number: cad_043_1 **Map Index:** 7
Property Type: Structure–Diversion, Turnout
Description: Gate No. ?
Significance: 4
Special Features: Concrete Mass, Steel Gate and Frame with Wheel on Screw Shaft

Ownership: Public, Denver Water
Additional Information: Appears operable

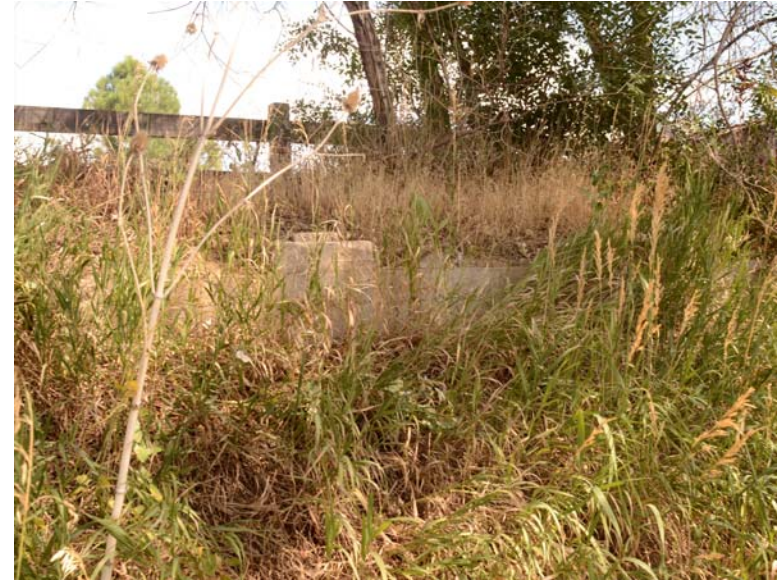
Site Number: cad_050_1; cad_051_1 **Map Index:** 7
Property Type: Structure–Access
Description: Bridge Abutments
Significance: 4
Special Features: Concrete Abutments, Bridges removed

Ownership: Public, Denver Water
Additional Information: Unknown reason for bridges in these locations.

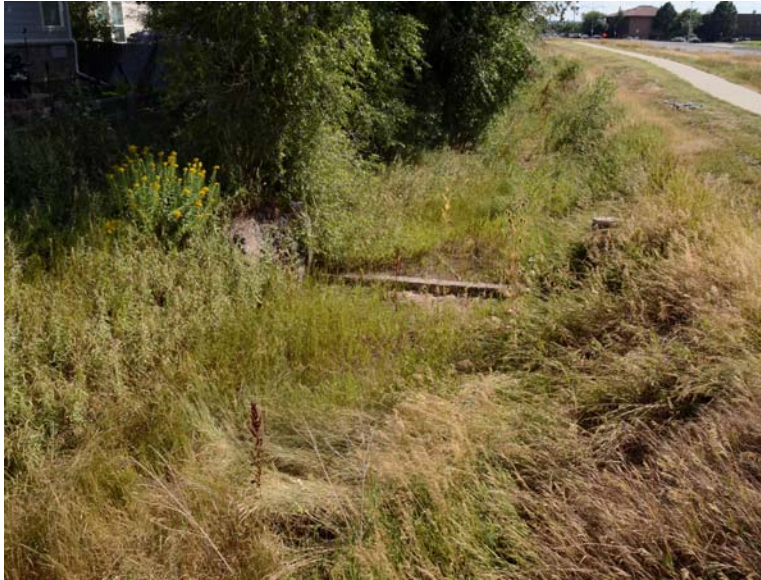
Site Number:	cad_053_1	Map Index:	7
Property Type:	Structure–Control & Measurement		
Description:	Check Dam		
Significance:	4		
Special Features:	Concrete base and Side Walls with slots for progressive planks		
Ownership:	Public, Denver Water		
Additional Information:	Appears unused for some time.

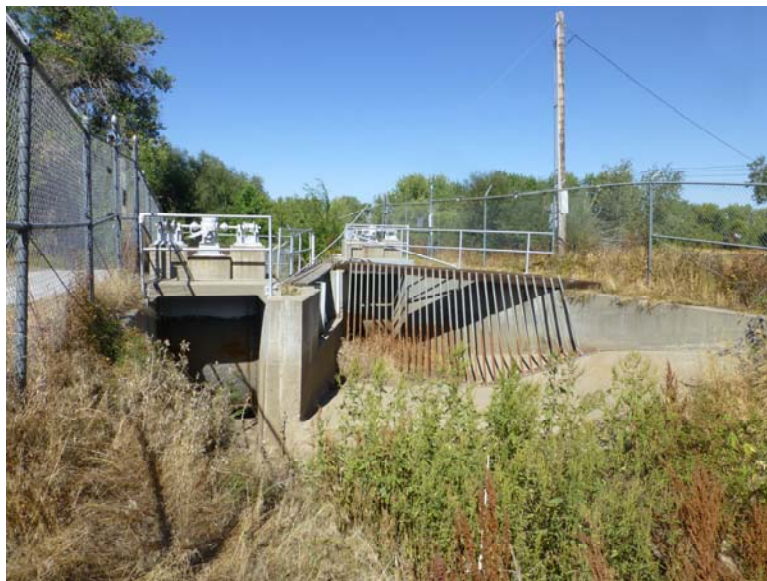
Site Number: bas_030_1; bas_031_1 **Map Index:** 8

Property Type: Structure–Conduit: Siphon.

Additional Information: Siphon Inlet (photo). Gates on Siphon Inlet and Wasteway are both hand-cranked gear boxes with cable-drums. Chain-link fence protects infrastructure. Also covers bas_031_2, concrete Siphon Outlet with Grizzly and chain-link fence protecting.

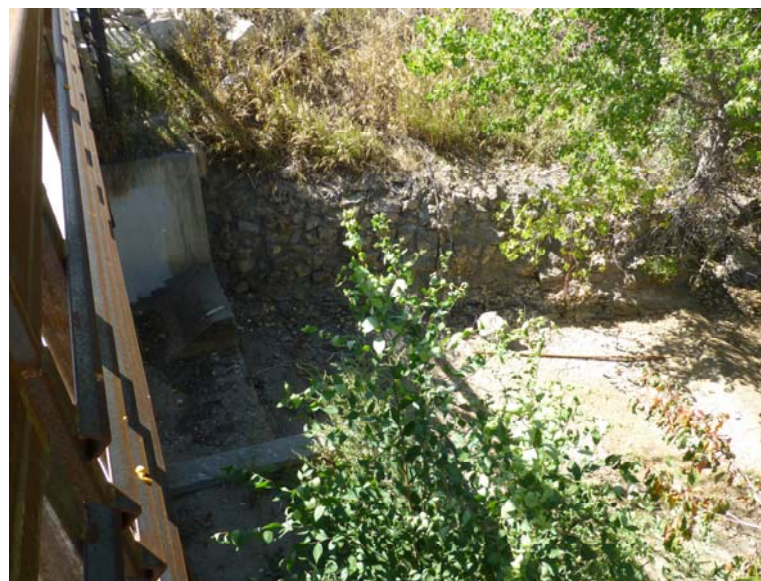
Site Number: bas_030_2 **Map Index:** 8

Property Type: Structure–Control & Measurement: Wasteway

Additional Information: Sand (or Coal) Creek bank protection at discharge of Wasteway Gate adjacent to Siphon Inlet.

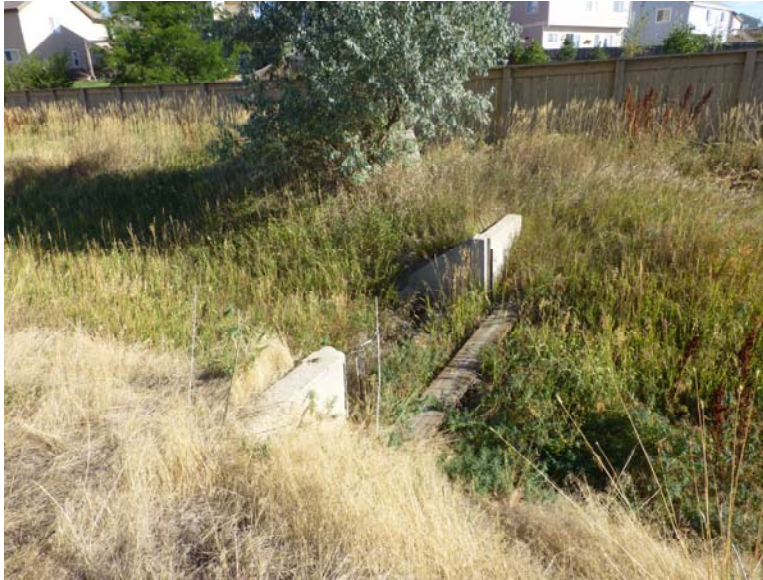
Site Number: bas_033_1 **Map Index:** 8
Property Type: Structure–Control & Measurement
Description: Check Dam
Significance: 4
Special Features: Concrete base and Buttressed Side Walls with slots for progressive planks

Ownership: Public, Denver Water
Additional Information: Appears recently used; backs water up for delivery to Turnout Gate bas_034_1.

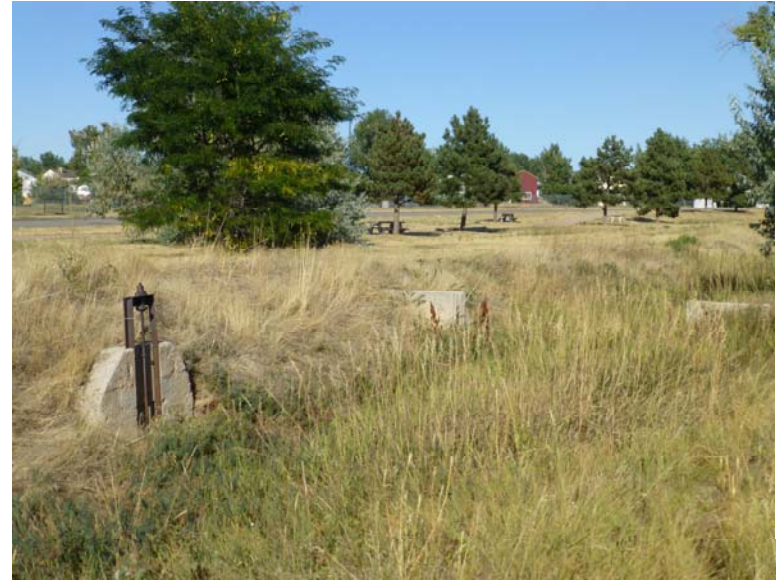
Site Number: bas_034_1 **Map Index:** 8
Property Type: Structure–Diversion: Turnout
Description: Gate No. ?
Significance: 4
Special Features: Concrete Mass with Steel Gate Frame.

Ownership: Public, Denver Water
Additional Information: Not in use, wheel missing from Screw Shaft.

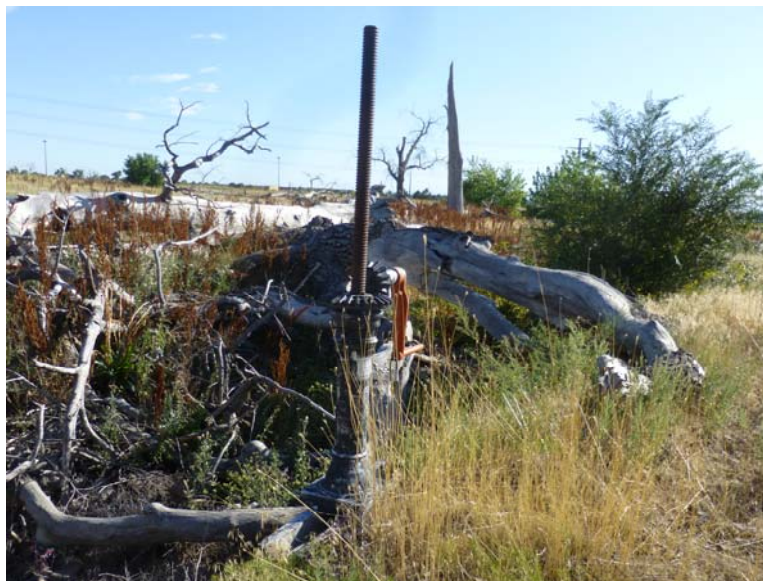
Site Number: bas_035_1; 5AM.261.15 **Map Index:** 8
Property Type: Structure–Diversion, Lateral Headgate
Description: Rocky Mountain Arsenal Headgate
Significance: 4
Special Features: Steel Gate Mechanism with hand-crank and pinion gears turning Screw Shaft; Concrete Mass not visible.

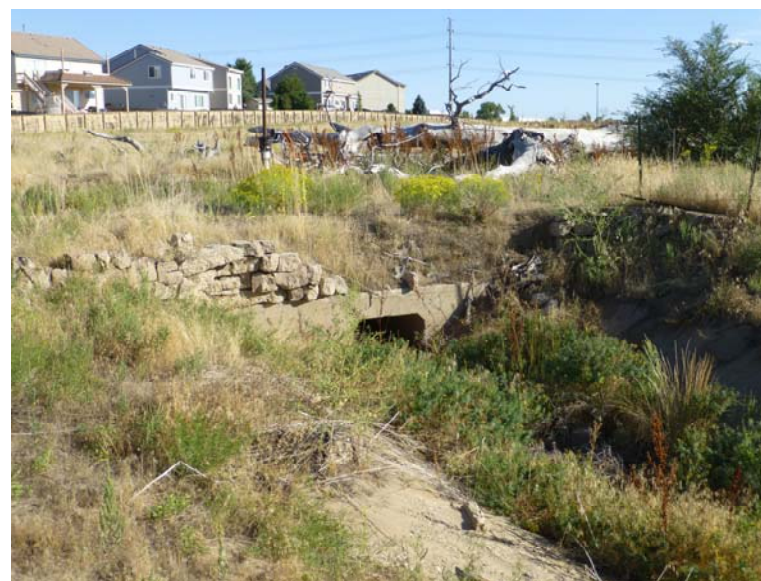
Site Number: bas_036_1 **Map Index:** 8
Property Type: Structure–Access Associated with Canal
Description: Rocky Mountain Arsenal Lateral Culvert
Significance: 4
Special Features: Concrete Culvert Outlet. Culvert and associated road remains in background.

Ownership: Private
Additional Information: Water from Headgate, 5AM.2615, flows through Culvert into concrete-lined Ditch for Measurement. Canal realigned in this area at unknown date.

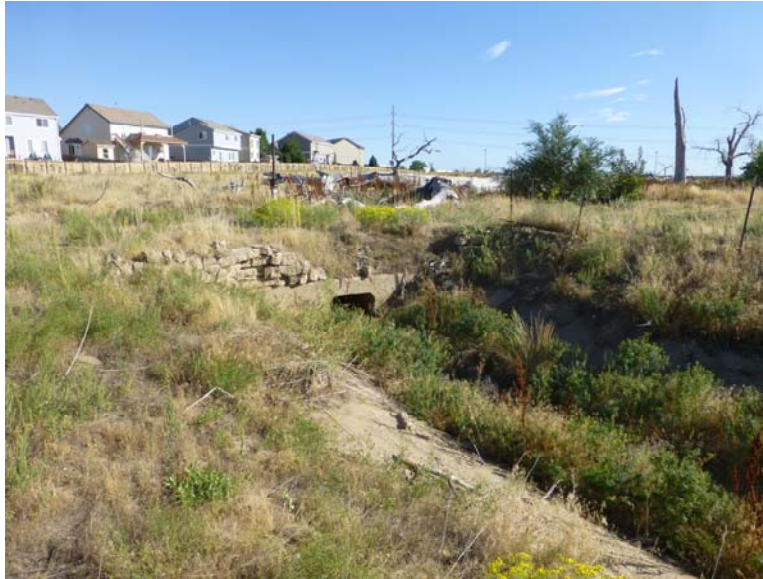
Site Number: bas_037_1 **Map Index:** 8
Property Type: Structure-Conduit
Description: Rocky Mountain Arsenal Lateral Forebay
Significance: 4
Special Features: Concrete-lined Ditch

Ownership: Private
Additional Information: Water from Headgate, 5AM.2615, flows through Culvert into concrete-lined Ditch for Measurement. Canal realigned in this area at unknown date.
 Also includes gauging station bas_038_1.

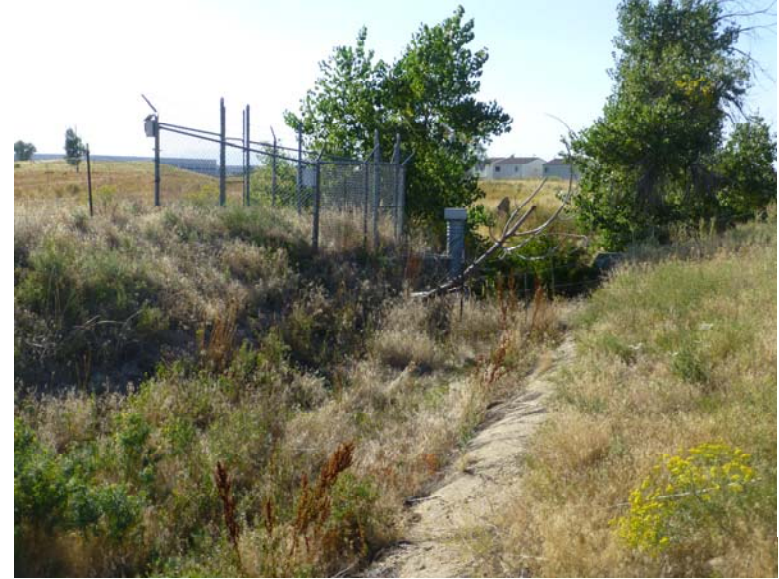
Site Number: bas_038_1; bas_039_1 **Map Index:** 8
Property Type: Structure-Control & Measurement
Description: Rocky Mountain Arsenal Measuring Station
Significance: 4
Special Features: Metal Measuring Devices protected by chain-link fence. Also weir shown in distance on right.

Ownership: Private
Additional Information: Water from Headgate, 5AM.2615, flows through concrete-lined Ditch to Measuring Station. Canal realigned in this area at unknown date.

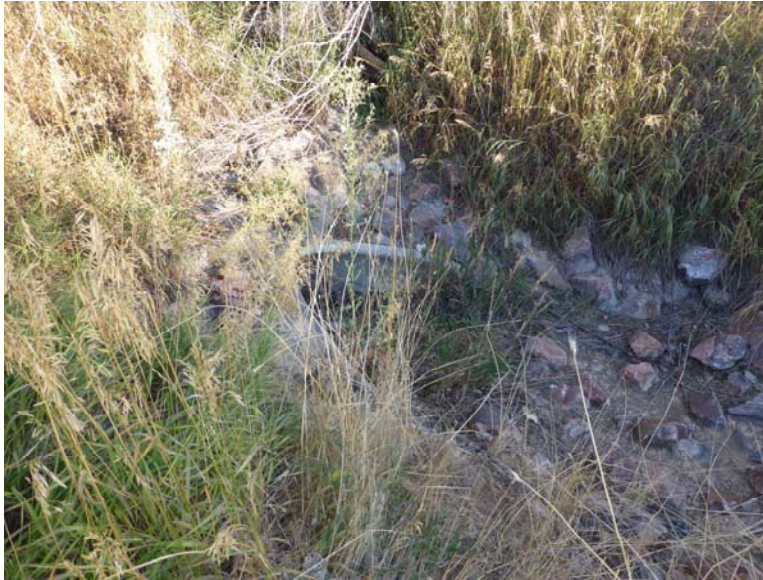
Site Number: bas_040_1 **Map Index:** 9
Property Type: Structure-Conduit: Siphon
Description: First Creek Inverted Siphon Inlet
Significance: 4
Special Features: Small Concrete Inlet, protected by rubble armor-
ing.

Ownership: Private
Additional Information: No evidence of Outlet.

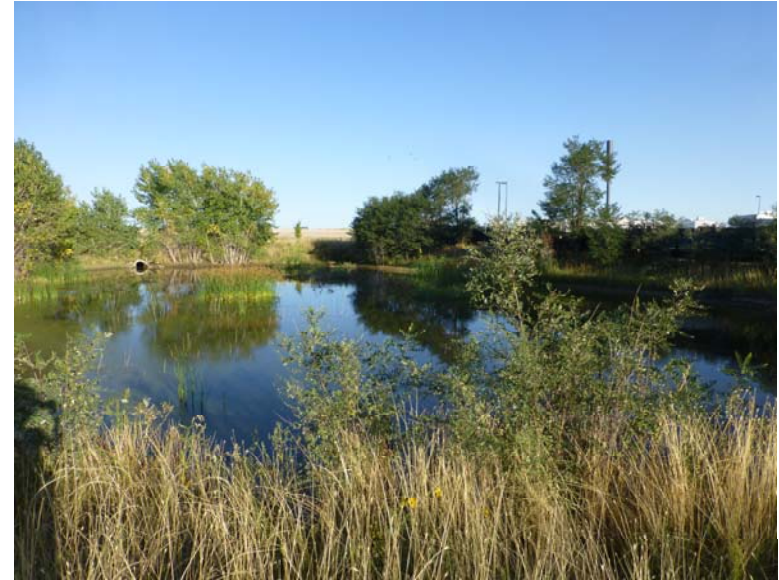
Site Number: bas_041_1 **Map Index:** 9
Property Type: Structure-Retention & Storage: Pond
Description: Pond near end of Canal
Significance: 2
Special Features: Earthen Berms create Pond. Need to verify if
pond is fed from Canal waters.

Ownership: Private
Additional Information: Overflow Drain in photo.

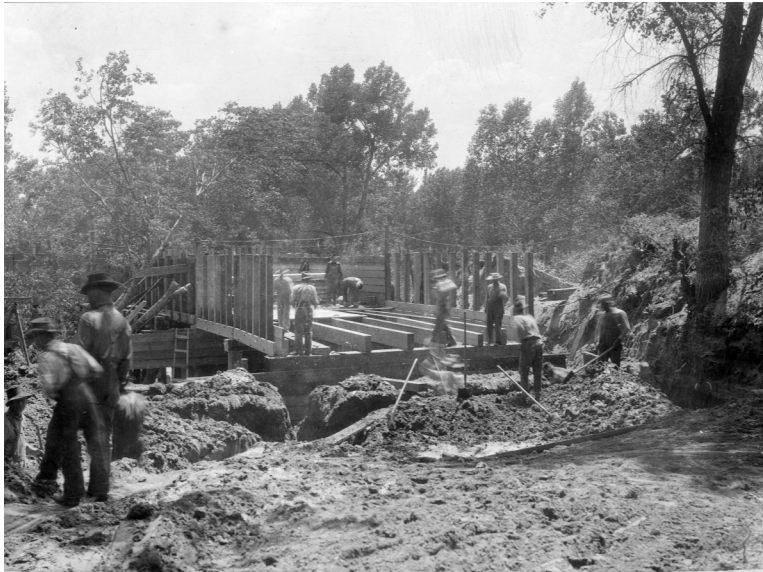
Exhibit 5-2: The photographic prints in the Denver Water Department's collection are well-labeled but variously organized. Above is photograph #1782 in Album 41-A, p. 54 with the caption "Views showing break in High Line Flume at Plum Creek and repairing of same." Photo is dated June 30, 1917.
